**Redegørelse i anledning  
af tre havarier  
med Dash8 Q400**

**Bilag til redegørelsens kap. 6**

**Hæfte 1**

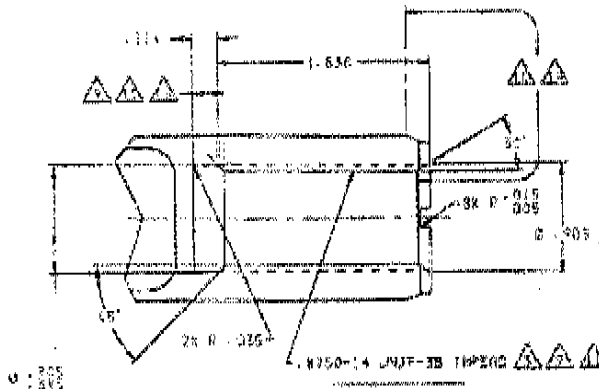
**VIEW A**

ITEM	PROBLEM DESCRIPTION
1	THERE HAVE BEEN 2 INSTANCES OF SEPARATION OF ROD END P/N P3A2750 AND PISTON P/N 46570-11-3. INSPECTION OF THREAD CONDITION REQUIRED INACCORDANCE TO TRANSPORT CANADA AIRWORTHINESS DIRECTIVE.
REPORTED CAUSE OF PROBLEM:	
ADDITIONAL INFORMATION ATTACHED <input type="checkbox"/>	
>> SEE SHEET 2 AND SUBS FOR MORE INFORMATION <<

1. DISASSEMBLE AS REQUIRED TO REMOVE ROD END P/N P3A2750 FROM ACTUATOR ASSEMBLY PER CMM REQUIREMENTS.
2. INSPECT - ENSURE NO EVIDENCE OF CORROSION ON ACTUATOR PISTON THREADS OR ROD END THREADS.
3. COAT ACTUATOR THREADS AND THREAD RELIEF AS WELL AS ROD END THREADS, WITH CIC MASTINOX 6865K.
4. RE-INSTALL ROD END ONTO ACTUATOR ASSEMBLY.
5. ADJUST ACTUATOR RETRACTED LENGTH USING TOOL CG 56806 REQUIREMENTS OR IN ACCORDANCE WITH CMM REQUIREMENTS.
6. TORQUE JAM NUT TO 660-980 IN-LBS AND SAFETY LOCKWIRE PER MS 33540.
7. COMPLETE PER UNIT CMM REQUIREMENTS (NOTE: FULL ACCEPTANCE TEST NOT REQUIRED).

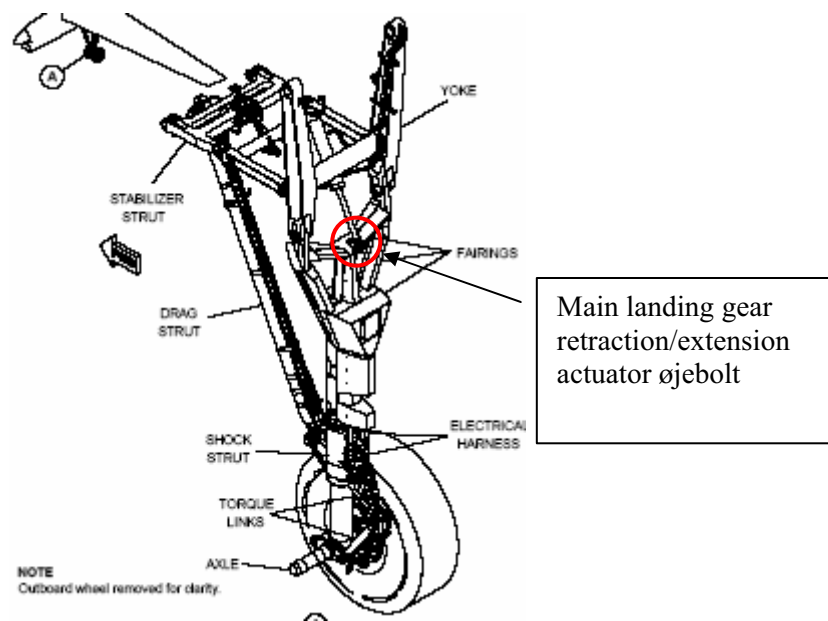
Under undersøgelserne blev det afdækket, at landingsstelsaktuatorens øjebolt var separeret fra aktuatorens stempel.

En undersøgelse af aktuatorstemplets indre gevind blotlagde tilstedeværelsen af korrosion, som har svækket materialet og ledte til separationen af øjebolten fra aktuatorstemplet. Denne separation var hovedfaktoren ledende til understellets kollaps.

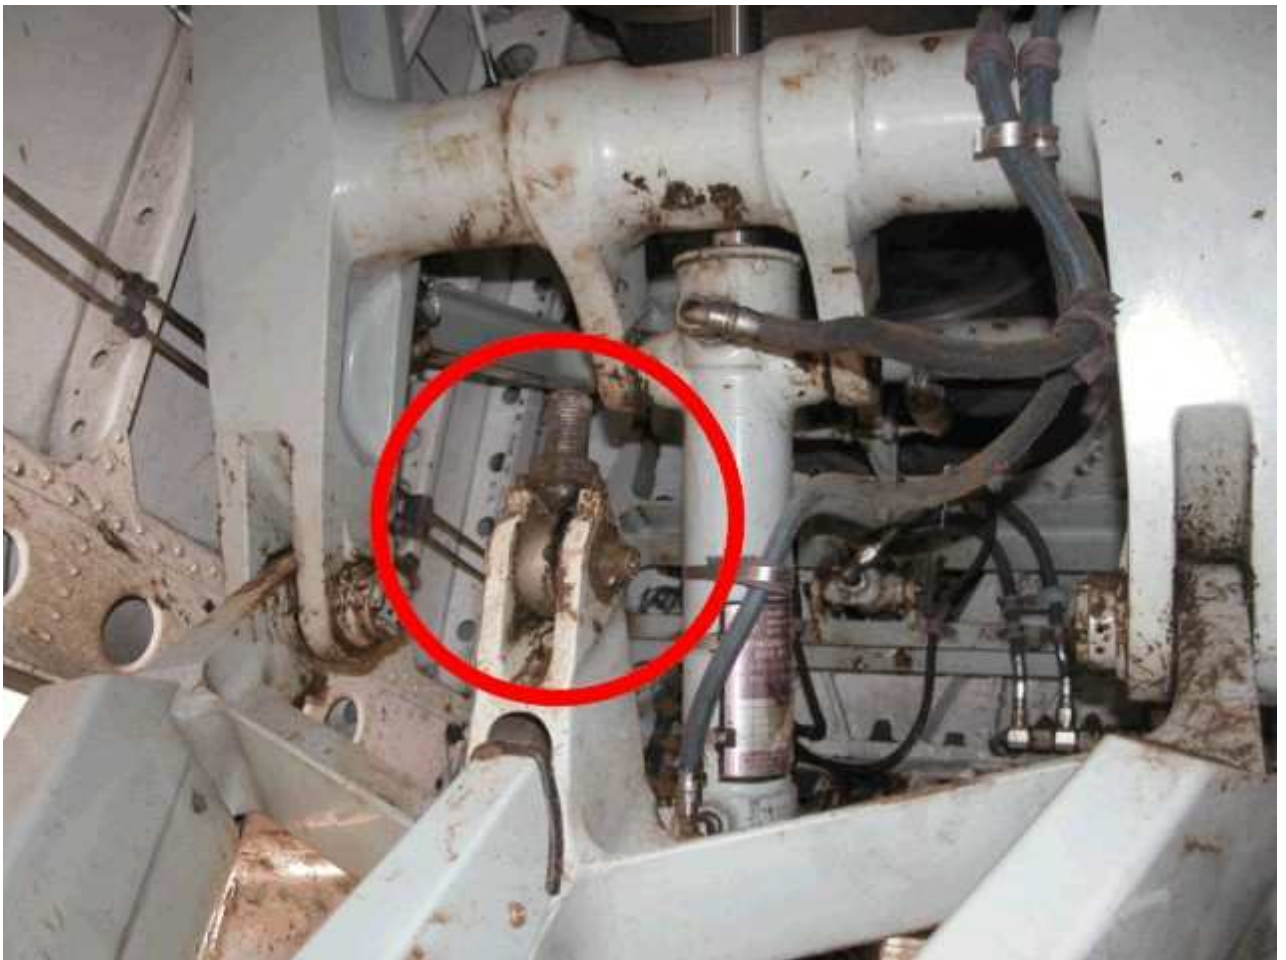
The examination of the Right Main Landing Gear showed separation of the retraction actuator rod end from its piston rod and two broken hinge lugs of the forward stabilizer brace assembly (see Appendix, Figure 1, Figure 2).

The examination of the piston rod and rod end in the laboratory indicated that the threaded connection between retraction actuator piston rod and rod end had suffered corrosion. Deterioration of the threads resulted in separation of the connection.

Figure 1: View of separated rod end.

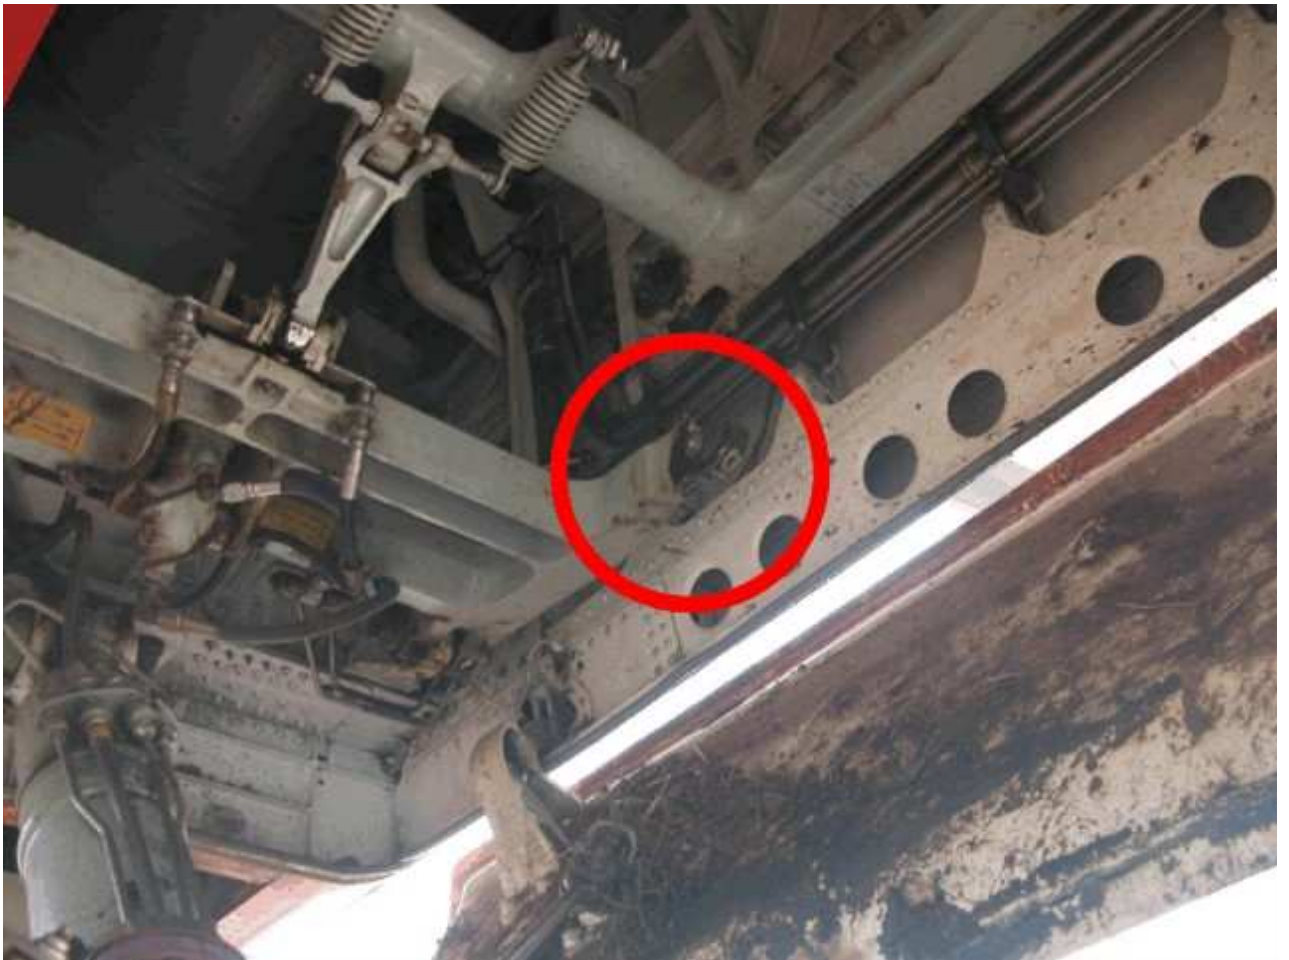
The examination of the fracture surfaces of the broken forward stabilizer hinge lugs revealed that the fractures were fresh, without any sign of previous cracks. It seems that the disintegration of the stabilizer was secondary damage caused by the separation of the actuator rod.

Figure 2: View of broken stabilizer brace assembly.
