**Redegørelse i anledning
af tre havarier
med Dash8 Q400**

Bilag til redegørelsens kap. 6

Hæfte 2

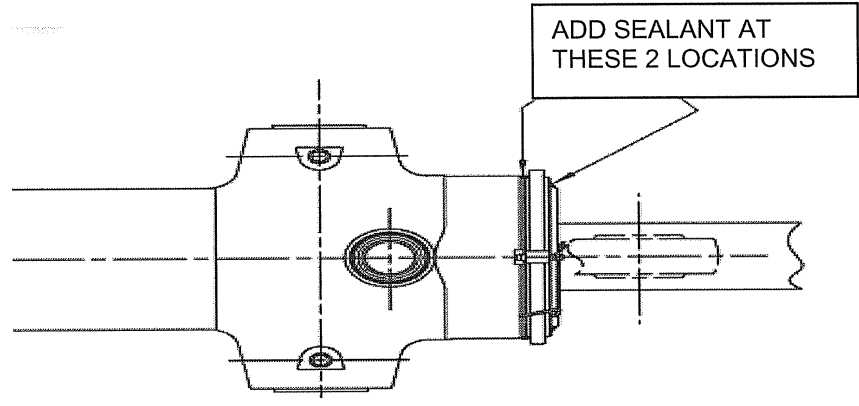
FIGURE 1

ITEM	PROBLEM DESCRIPTION
1.	CYLINDER PN 46551-1 HAS EVIDENCE OF CORROSION ON GLAND NUT THREADS.
2.	GLAND NUT P/N 46572-5 HAS EVIDENCE OF CORROSION ON THREADS.

1. CLEAN THREADS USING A STAINLESS STEEL WIRE BRUSH AND SOLVENT, TO REMOVE ALL F.O.D AND CORROSION BY PRODUCTS
2. VISUALLY INSPECT THREADS AND THREAD RELIEF AREA FOR EVIDENCE OF PITTING AND DAMAGE TO THE THREAD FORM USING 10 X MAGNIFICATION

3. IF THREADS ARE FOUND WITH **LIGHT SURFACE CORROSION ONLY** (I.E. NO PITTING OR THREAD FORM DAMAGE) PROCEED WITH OPERATIONS 5 THRU 10 UNDER PART 1 OF THIS SCR

4. IF THREADS ARE FOUND TO HAVE PITTING OR DAMAGE TO THE THREAD FORM THEN CONTINUE WITH **SECTION A** OF THIS SCR.
5. LIGHTLY CHASE THREADS USING A WIRE BRUSH OR THREAD COMB AS REQUIRED TO REMOVE ALL EVIDENCE OF CORROSION.

6. LIGHTLY POLISH THREAD RELIEF AREA AND ADJACENT CHAMFER AS/IF REQUIRED TO REMOVE ALL EVIDENCE OF CORROSION.
7. INSPECT – ENSURE ALL EVDIENCE OF CORROSION HAS BEEN REMOVED (NO PITTING) AND THAT THREAD FORM REMAINS UNDAMAGED, USING 10 X MAGNIFICATION.

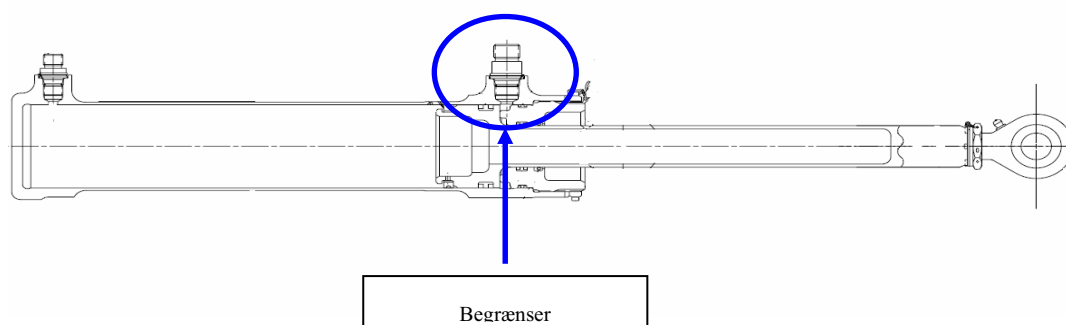
Nedenstående figur viser højre understels aktuator (retraction/extension actuator assembly) og placeringen af den blokerede begrænser.

Begrænseren (retraction/extension actuator restrictor valve) var blokeret af en O-ring. O-ringen kom ikke fra aktuatoren, og dens oprindelse er indtil videre ukendt.

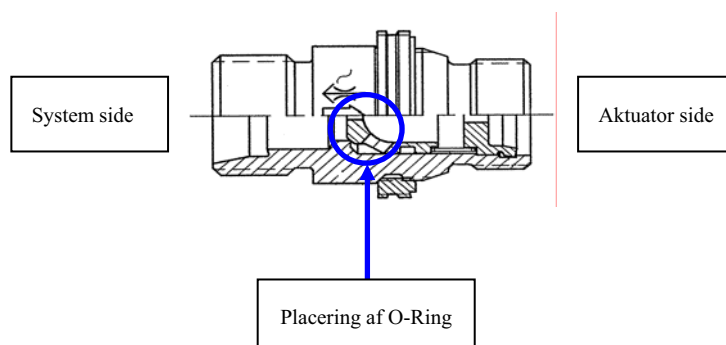
Nedenstående figur viser begrænseren (retraction/extension actuator restrictor valve) og den position, hvor O-ringen som blokerede begrænseren blev lokaliseret.

Den utilsigtede tilstedeværelse af O-ringen og de deraf afledte konsekvenser, vurderes på det foreliggende grundlag til kun at berøre dette luftfartøj.

Den videre undersøgelse vil fokusere på oprindelsen af O-ringen.

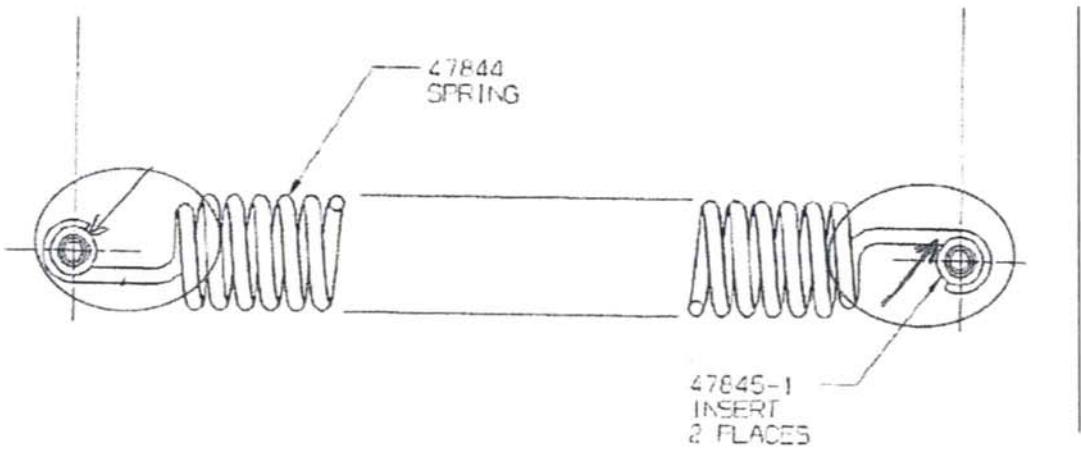
Report findings and illustrate:
FOUND SHAFING ON RETAIN SPRING
AROUND RETAINER
NO Findings FPI
