Lessons to be Learned from the  
"SCANDINAVIAN STAR" Disaster

Hans Christensen  
director deputy

**Lesson to be learned from  
the Scandinavian Star Disaster of 7 April 1990**

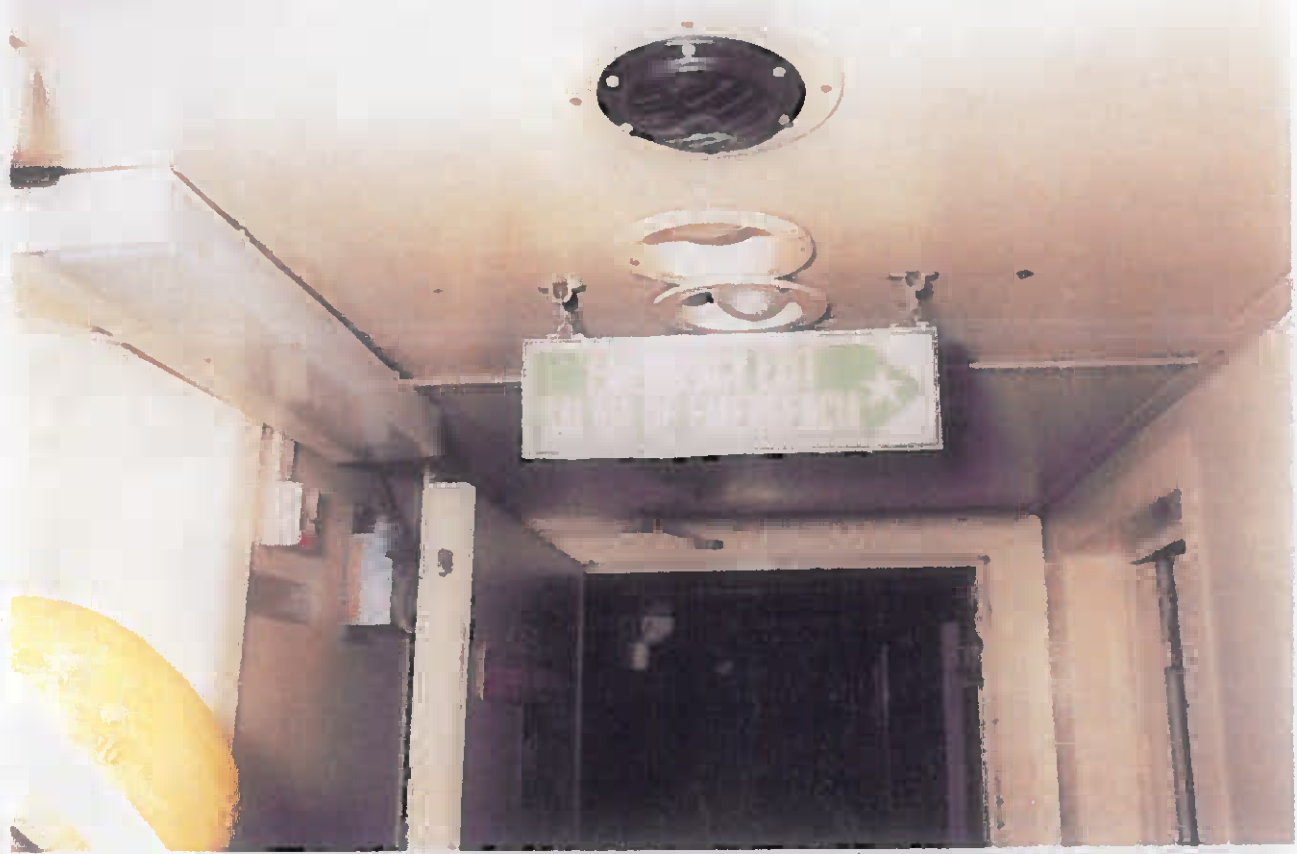
### Signposting

**Note: Location of the signposting in the "smoke zone"**

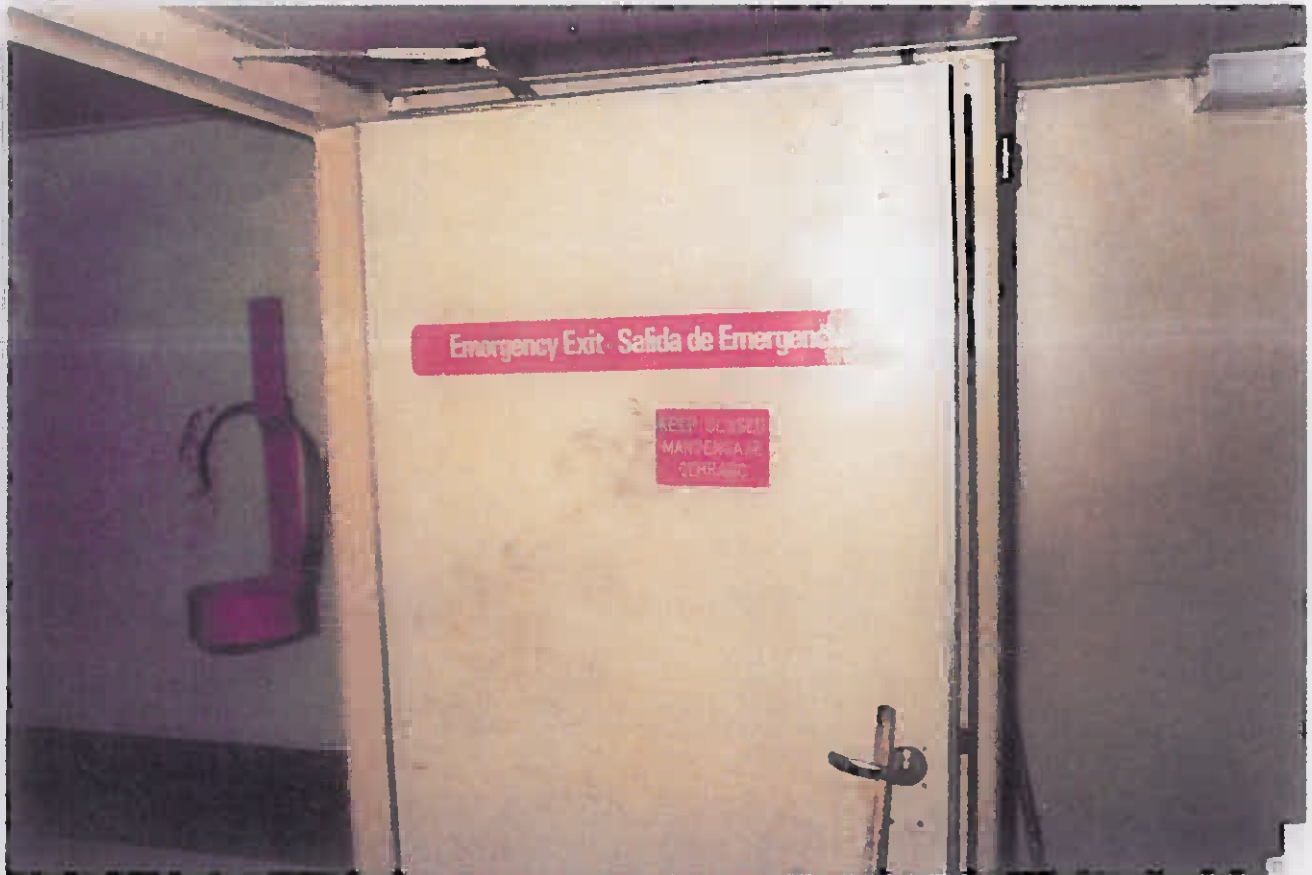
## Signposting

**Note: The language used is not appropriate. Should have been a "Scandinavian" language**

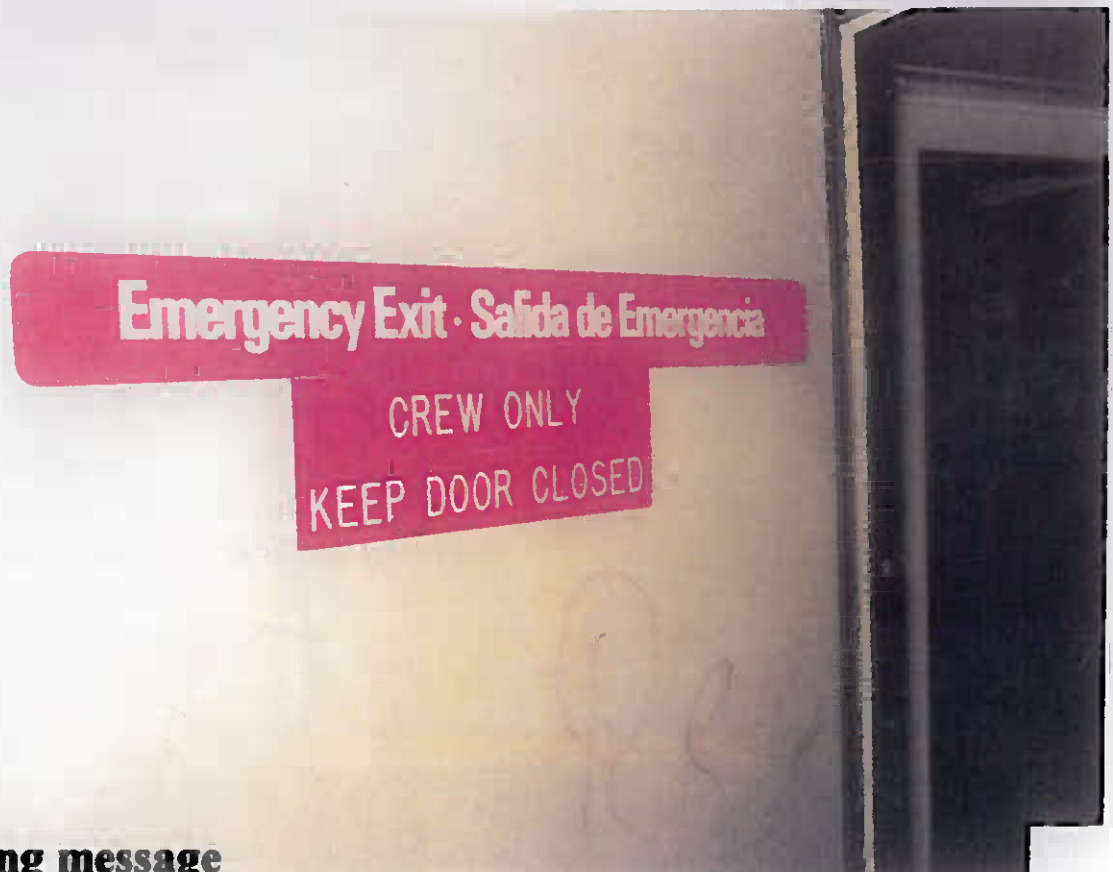
**Note: Confusing message**

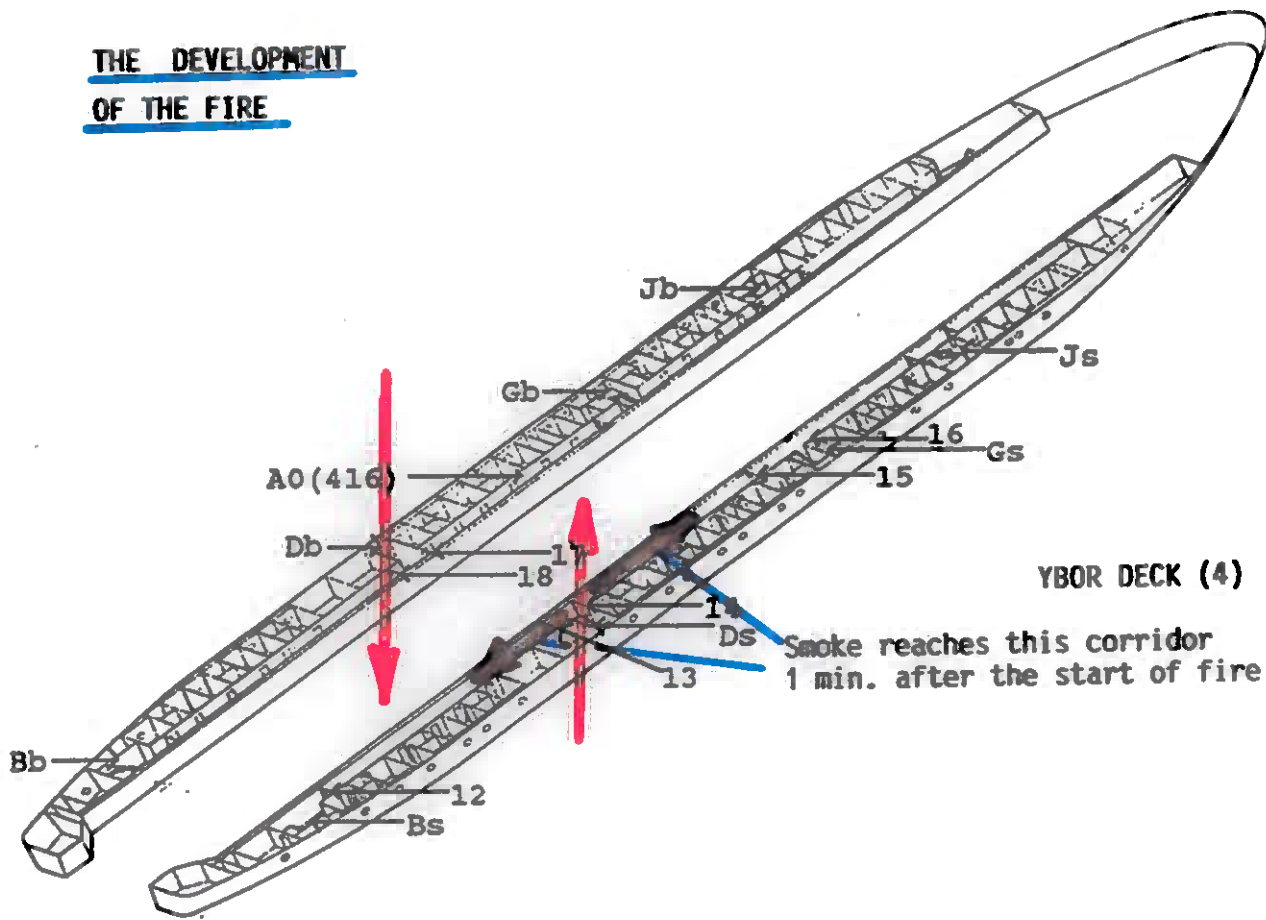
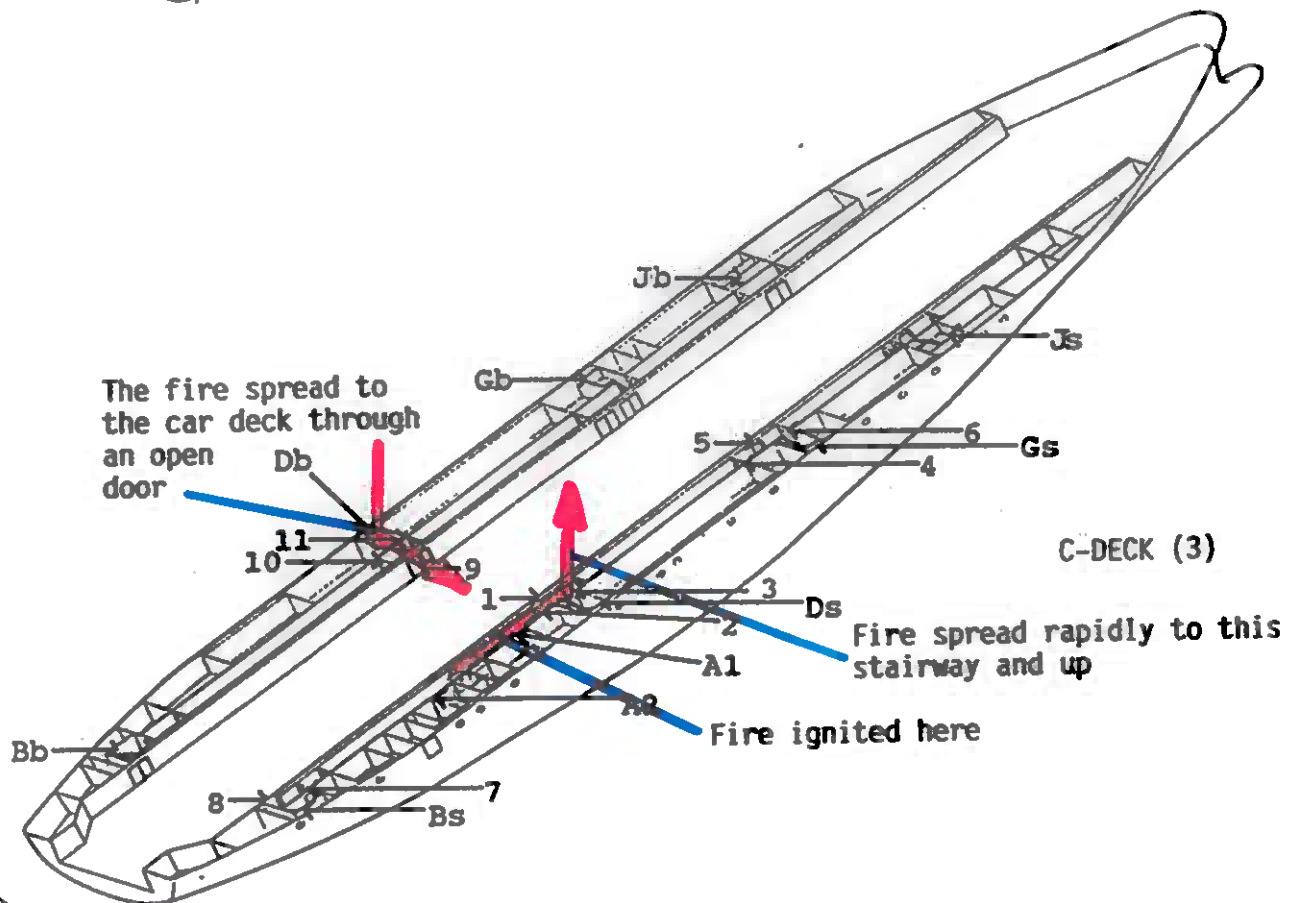
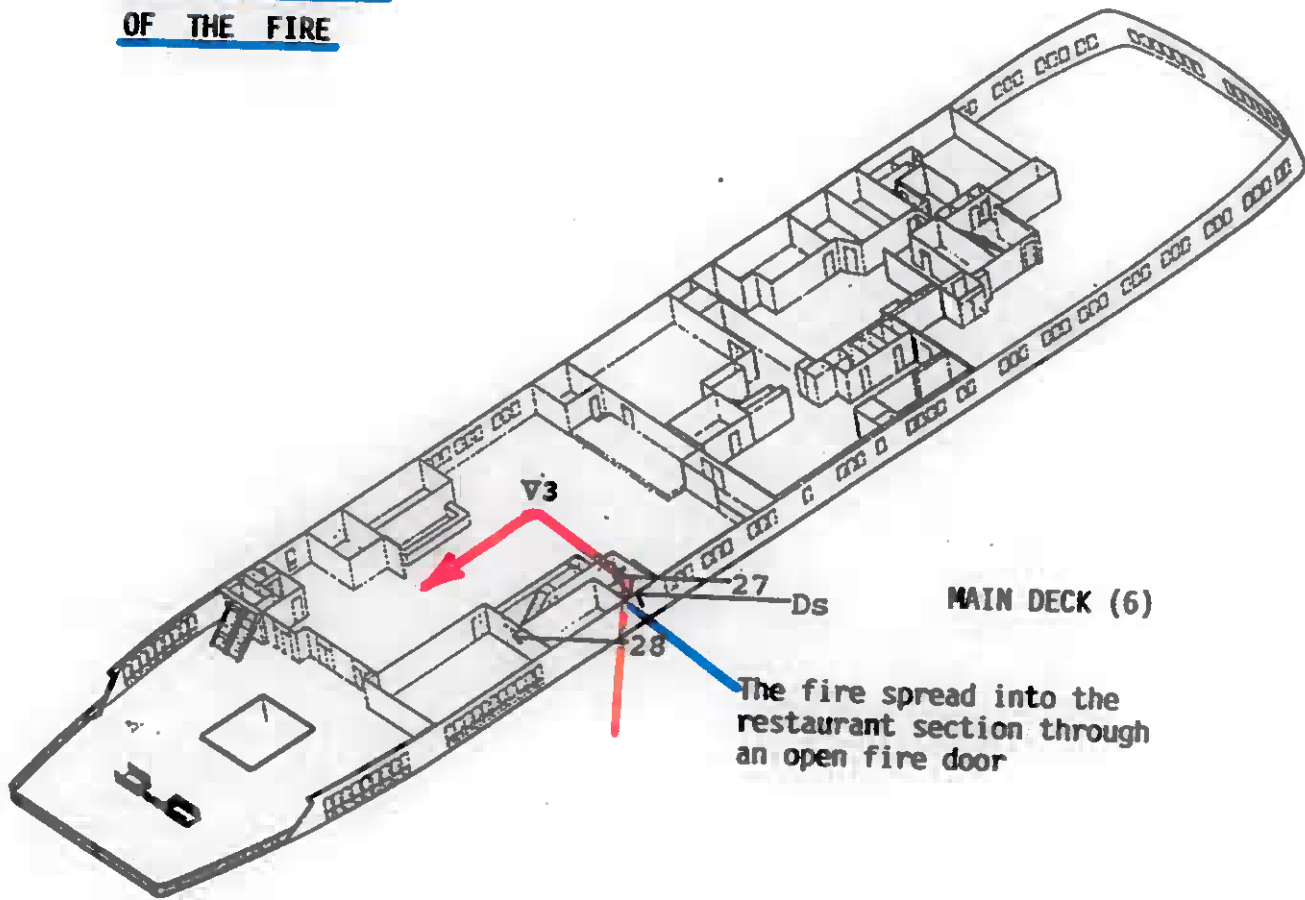
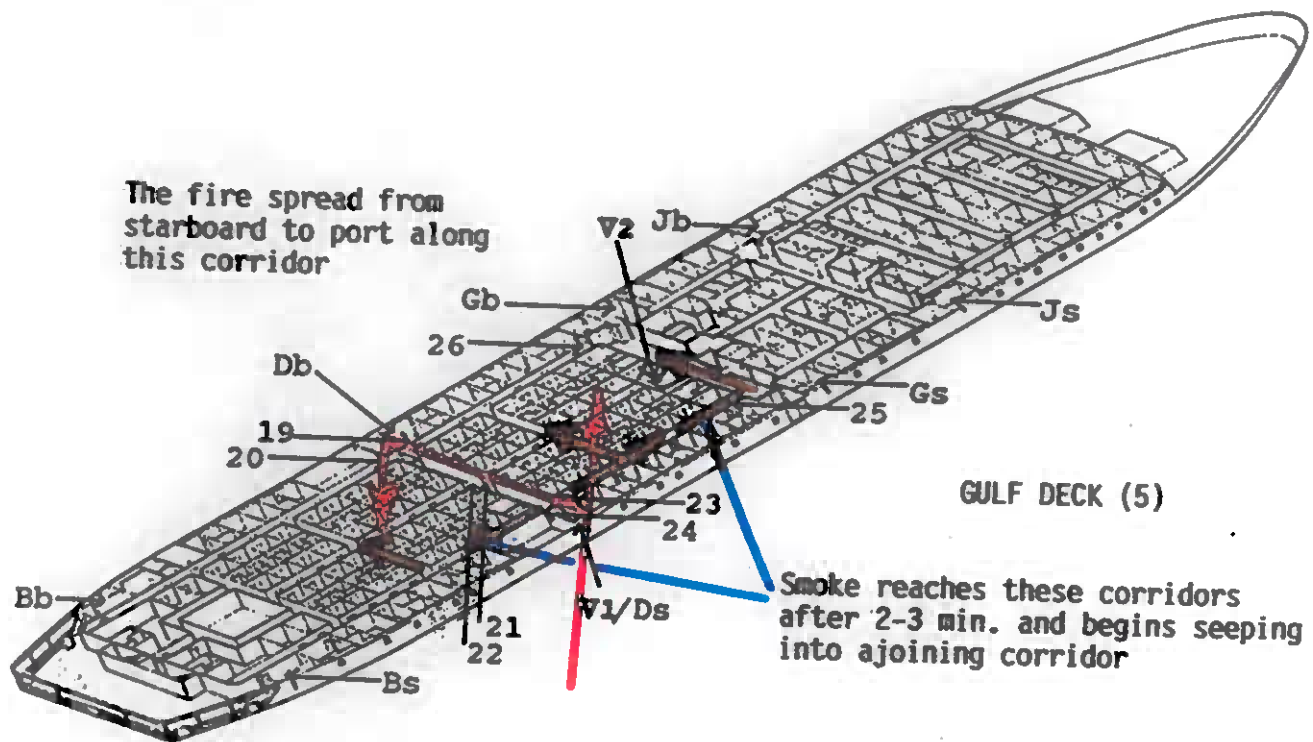
**THE DEVELOPMENT  
OF THE FIRE**

The fire was probably started some time after 0200 hours on April 7, 1990. The site of ignition was almost certainly the corridor area on deck 3 adjoining the entrance to a stairway leading up to the cabin area. (Re. Figure 2). The cabins on this deck was not in use during this voyage. There is little doubt that the fire was ignited with a naked flame, about the size of a match or a lighter flame. The ignited material is assumed to have been a collection of paper, bedclothes etc. Two to eight minutes after the fire was ignited, the fire had attained an effect great enough to ignite the surface material on the bulkheads in the corridor. From this point onward the fire spread rapidly. One minute after the corridor surfaces caught fire, the whole cross section of the corridor was aflame. The fire was drawn to a nearby stairway, and smoke was drawn up through the staircase and into the corridor above connected to the staircase. Two to three minutes after the fire had started, smoke was observed seeping into deck 5, and two minutes later on deck 6. The fire was signalled from deck 5 by use of the press button alarm.

The flames also began spreading up the staircase, and when they reached deck 5, they were directed across the transverse corridor to the corresponding staircase on port side and down to deck 3. This spread went extremely fast. Witnesses have described it "a ball of fire" that flashed through the transverse corridor. Smoke also began seeping into the corridors from the staircase on the port side of deck 4. There was less smoke here than in the other areas, however, and after the fire no corpses were found in the corridors on the port side.

The primary, life threatening fire was now limited to the site of ignition, the starboard and port staircases and about half of the transverse corridor on deck 5. The material that was burning mostly consisted of the surface material in the corridors and in the staircases. The extreme rapid development of the fire during this phase was over in about 10 to 15 minutes. After this the fire spread more slowly from this area to the rest of the ship.

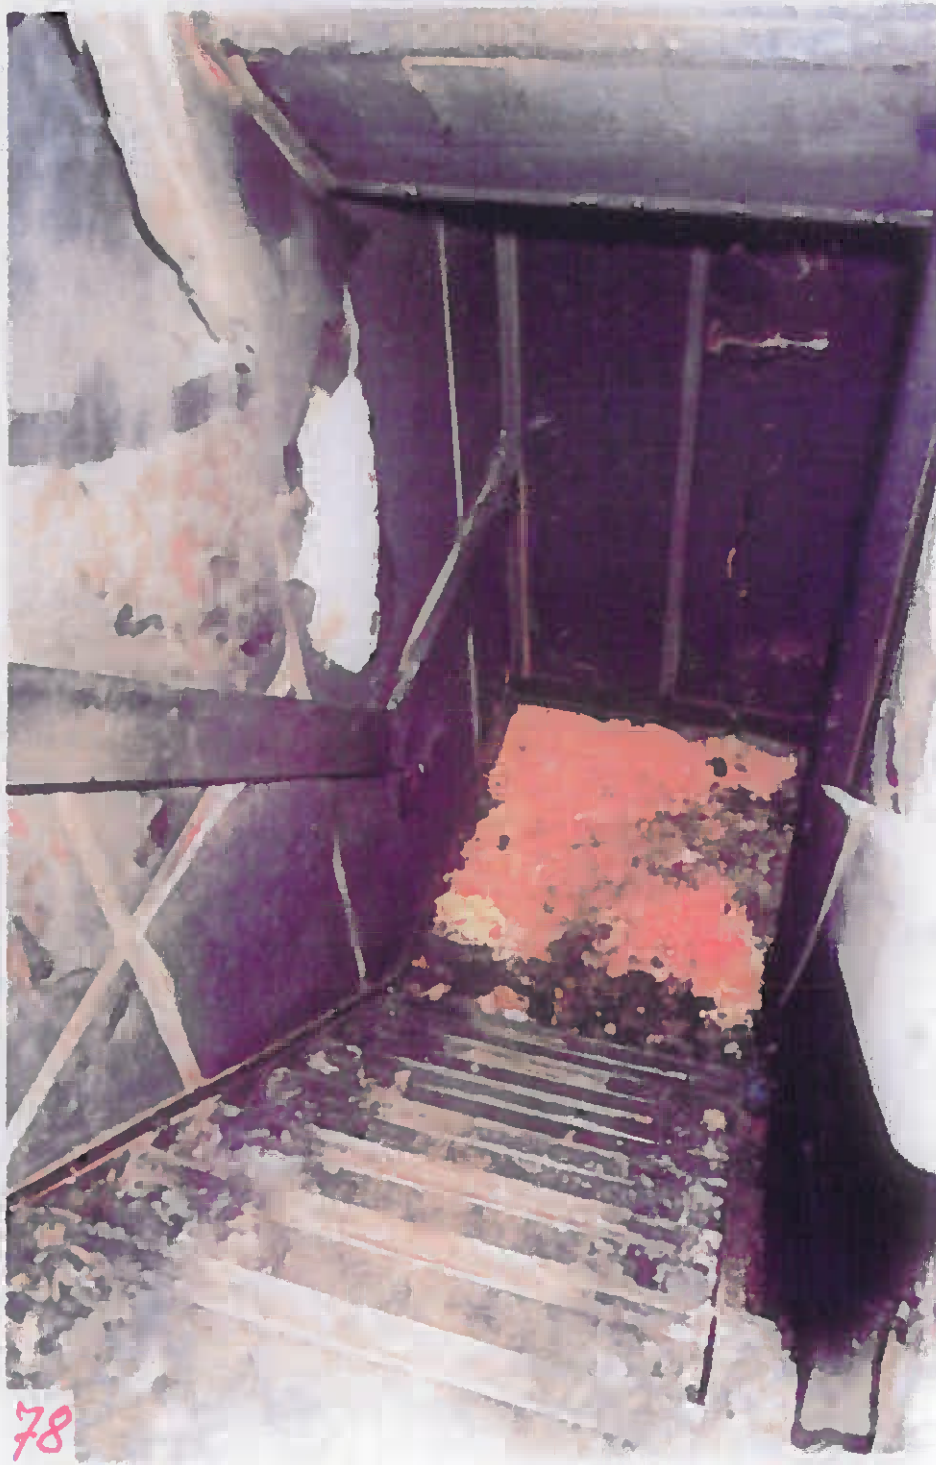
**Staircase "Db", port side, from Ybor deck (4) downwards**

The development of the fire proved beyond doubt that the material used to line the bulkheads, the ceiling and the deck in the corridors and staircases caused the fire to spread rapidly and produce large amounts of toxic smoke. The material used consisted of a core of non combustible material surfaced with laminated plastic about 1.5 mm thick. The calorific value was afterward tested to 48 MJ/m<sup>2</sup>. It should be noted that the required calorific value in SOLAS 74 is 45 MJ/m<sup>2</sup> for such material. As can be seen, the calorific value of the surface

material on this ship was only 3 MJ/m<sup>2</sup> above the present requirement. Nevertheless, this laminated plastic was decisive for the rapid spread of the fire, especially since it formed an uninterrupted surface covering the walls and the ceiling in all corridors and staircases. If the surface in the ceiling had been made of a material having a much lower calorific value, this would not have allowed the flashover in the corridor and thereby restricted the spread of the fire. This has later been proved by a full scale testing of a corridor, constructed of the same material and creating conditions similar to the conditions of this fire. During the early intense phase of the fire large amounts of gray black toxic smoke were developed. Carpets and furniture had no particular influence on the development of the fire.

**STRUCTURAL FIRE PROTECTION  
IN EXISTING PASSENGER SHIPS IS  
NOT SATISFACTORY**

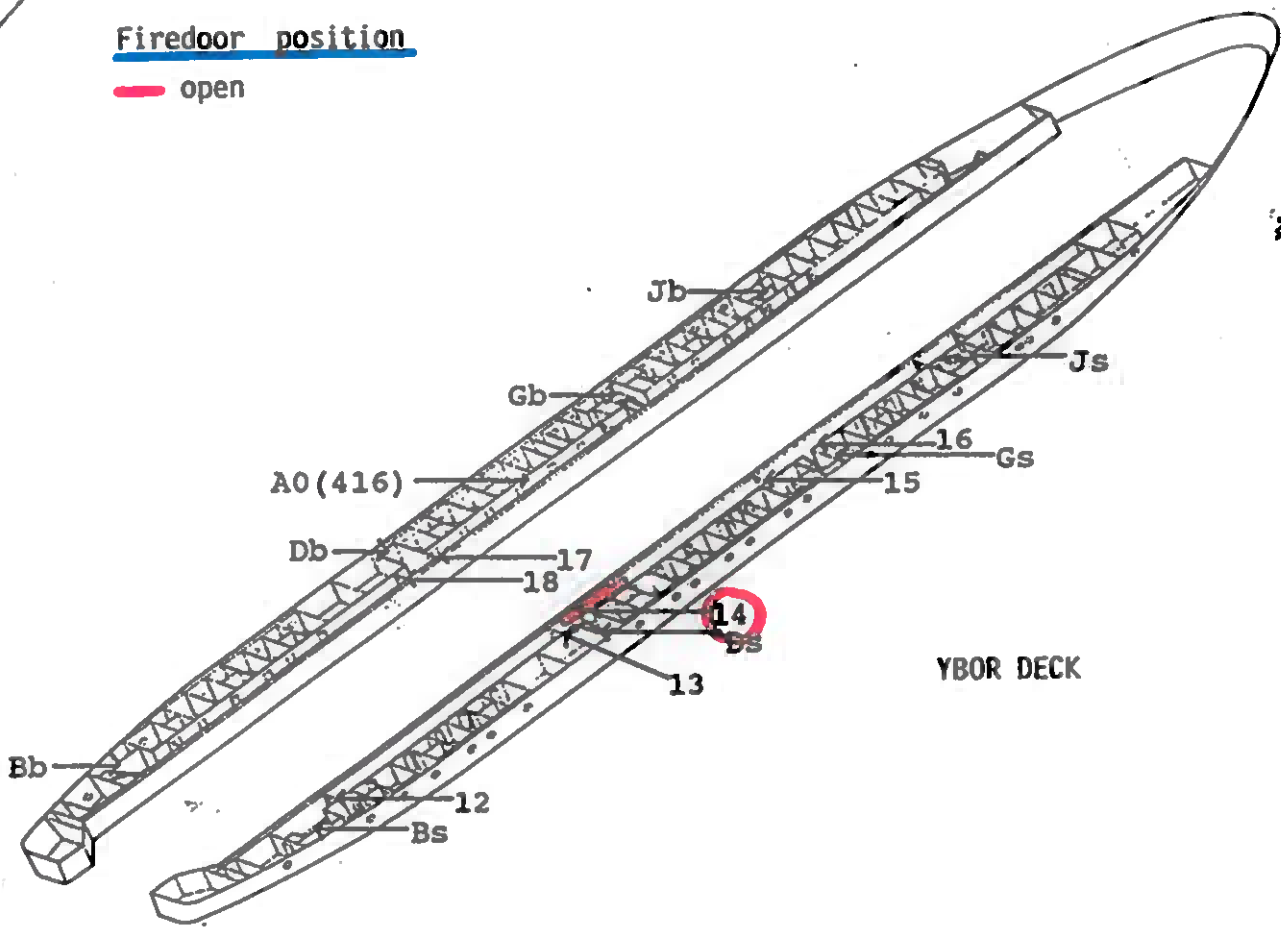
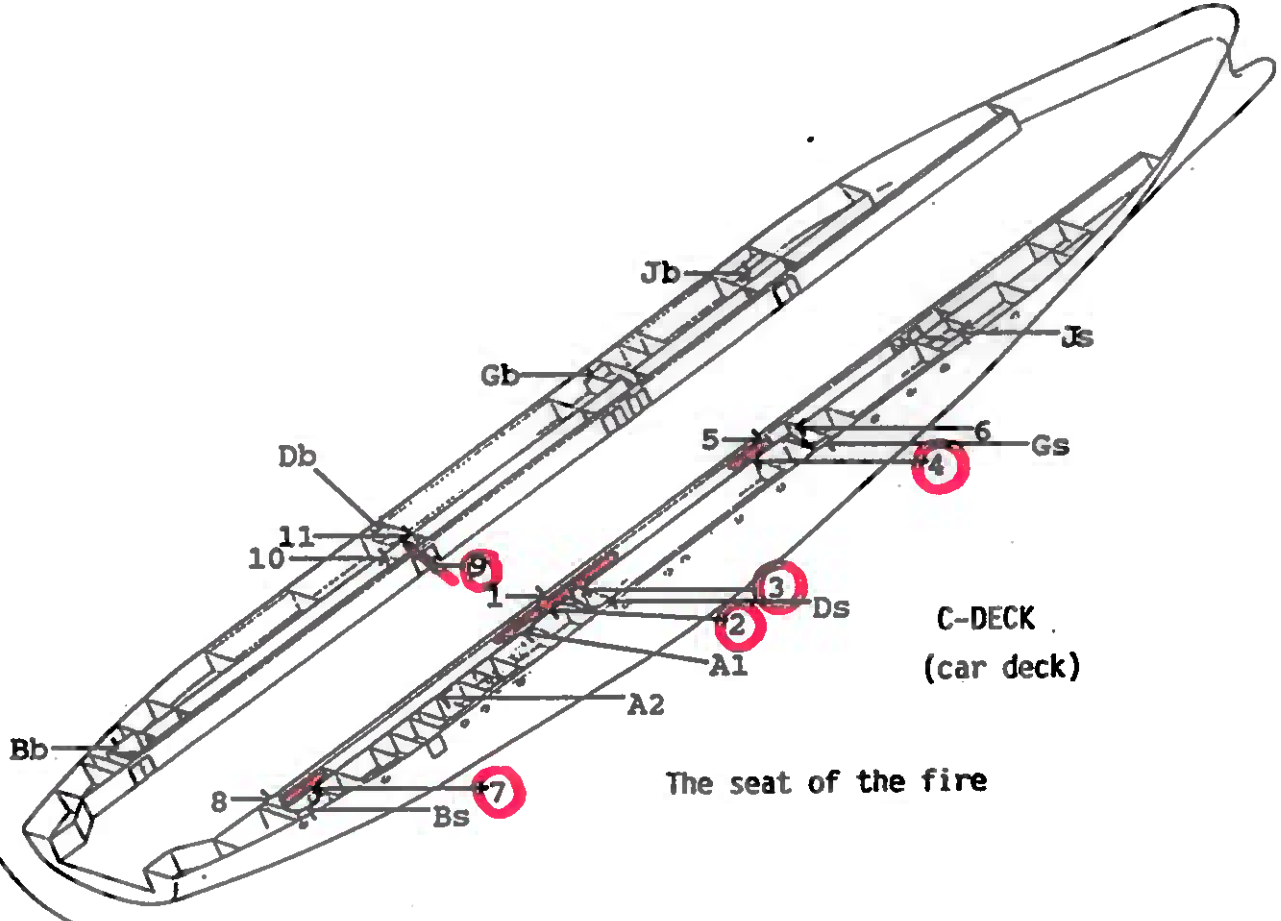
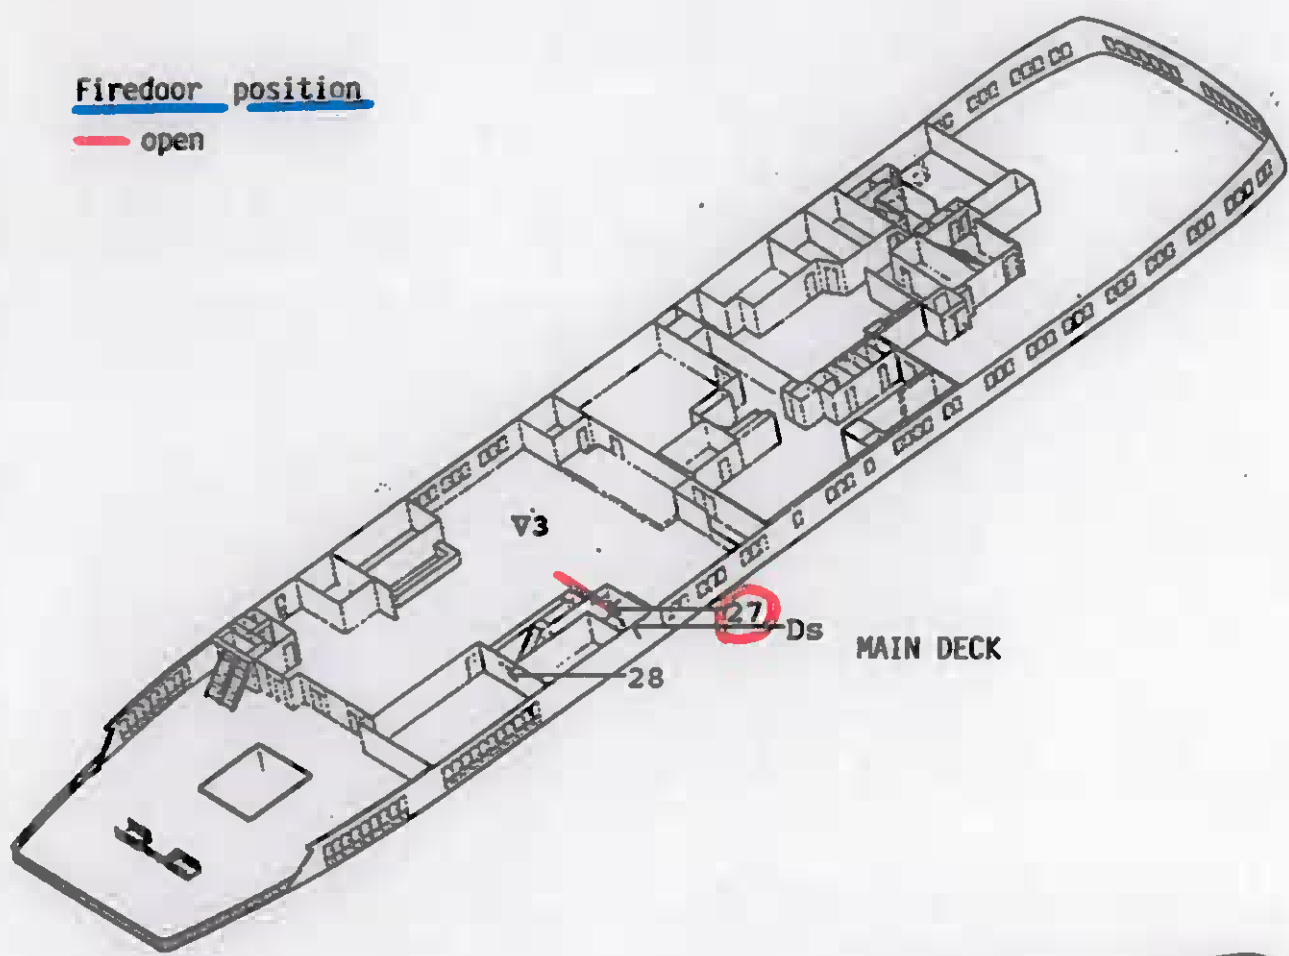
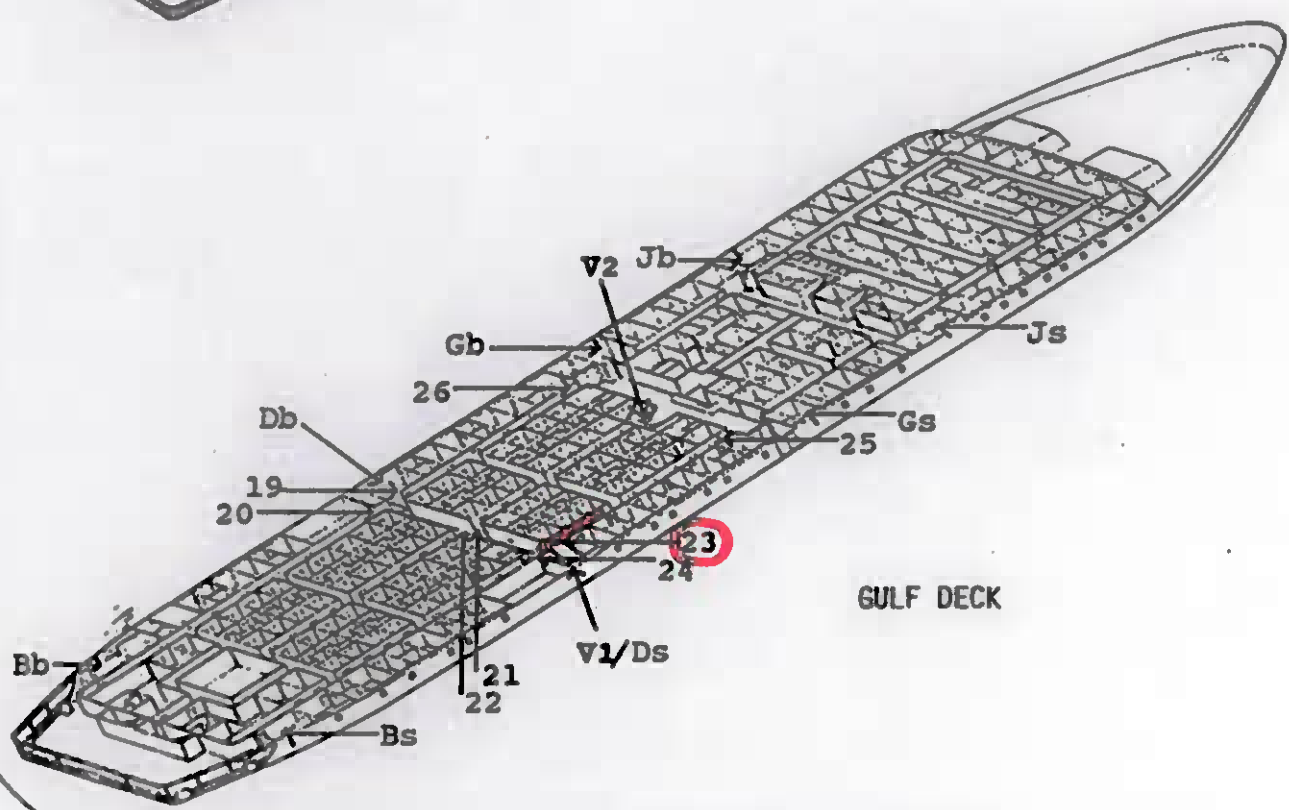
Firedoor position

The fire doors is of great importance for the development of the fire, why the function of these during the fire will be explained. The doors in this ship is normally kept open by magnetic catches, which can be released from the bridge. One of the reasons why the limited initial fire developed into a major fire, was that no alarm was ever given from deck 3, where the fire started. This was probably due to the fact, that nobody was present to press the alarm button. Thus the fire door leading from this zone to the staircase was never closed, and the fire was allowed to spread. If the door had been closed early enough, further spread could have been avoided. Most of the doors were eventually closed. Although it has not been possible to establish the exact time. However, some of the fire doors in the areas affected by the fire remained open during the fire. One of the doors, which remained open, was the door leading from the staircase to the cardeck in the portside, opposite the site where the fire started. This created a draught in the corridor, which greatly influenced the development of the fire. The fire doors greatly affected the course of the fire because, together with the ventilation system, they influenced the supply of air to the fire. Closing of the fire doors and turning off the ventilation is supposed to cut off the air supply. The fact that some of the fire doors remained open while others were closed, is one

of the main reasons why the fire spread so rapidly and why the smoke affected such a big area. Furthermore the transverse corridor between the starboard and the port staircase on deck 5 created favorable draught conditions.

The fire doors also proved to be a very critical and decisive factor. In the corridors, where they closed before the area was ignited, they proved to be a very effective means to prevent the fire from spreading. Some of the doors were totally scorched on the side facing the fire, while on the other side no damage or only very limited damage could be observed. Some of the doors did not close, however, and allowed the fire to spread into the areas beyond the door. It is not known if some of these doors were closed at an early stage, and later opened for the passage of people and then afterward did not close again. There are at present no requirements in SOLAS for the fireresistance and the mechanical function of the self closing mechanism on the doors. The fact that some of the fire doors closed and others remained open also affected the course of the fire. Together with the ventilation system they influenced the supply of air to the fire. The open corridor between the stairways starboard and port on deck 5 created favorable draught conditions, which further helped the fire to spread rapidly.

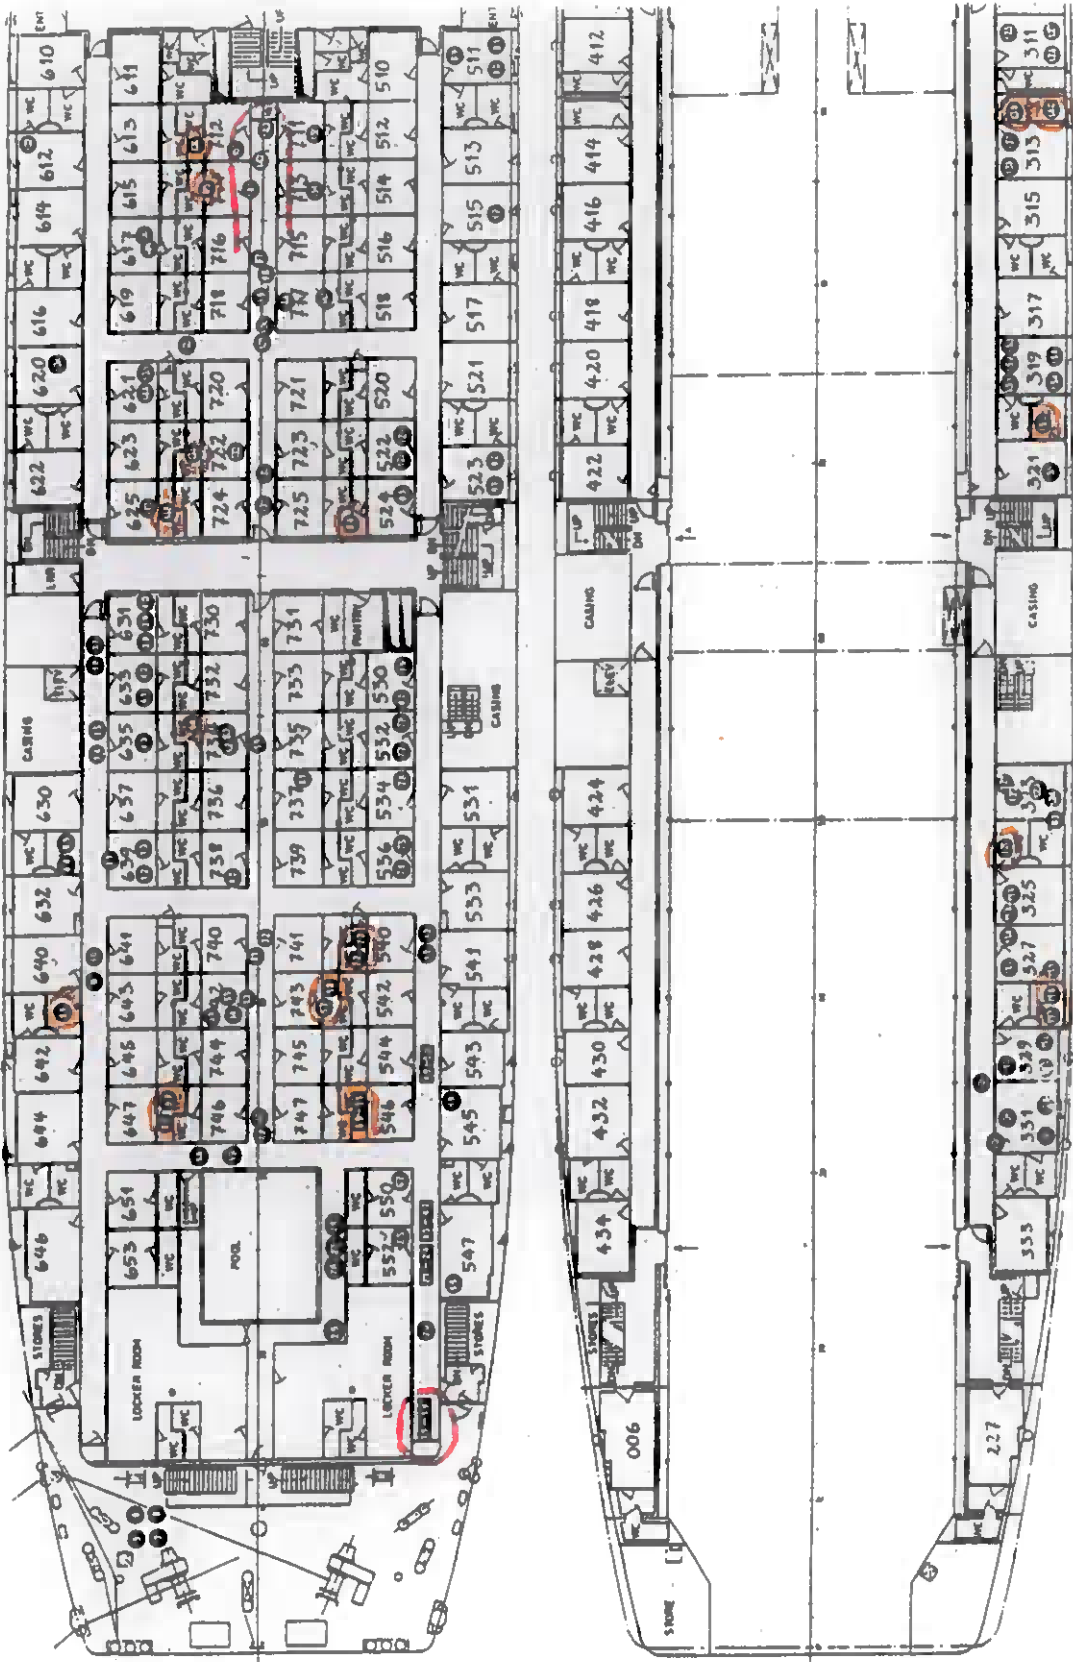
# WHERE THE BODIES WERE FOUND

Most of the bodies, 99 in all, were found in their cabins. About 25 per cent of these were found partly or completely inside the bathroom, often with towels over their faces. This type of reaction, where passengers seek to obtain fresh air rather than trying to escape through a smoke filled corridor, has also been noted in other fires. Those who were found in the sleeping compartment of their cabins, seem to have had varying reactions. Some were fully dressed, while others were only partly dressed, or in their underclothes, which seems to indicate that they have become aware of the fire at a relatively late stage. A good 50 of the passengers were found in the corridors, mainly in the aft part of deck 5. Conditions in the escape routes must have been extremely difficult with dense toxic smoke and little light. Furthermore the arrangement of the escape routes was complicated, involving many changes of direction, and some of the corridors had dead ends. About 20 of the bodies were found in the dead end corridors. There were doors in these corridors, but they were situated about 3 meters from the end of the corridor.

- 99 bodies in their cabins, of which**
- 25 were in the bathrooms**

- 50 bodies in the corridors, of which**
- 20 were in dead-end corridors**
