SCANDINAVIAN STAR

Fire on board 070490-080490

FIRE INVESTIGATION

Preliminary study
Malmö, Sweden, 2009-07-09
SWECO Fire Protection Engineering and Risk Management

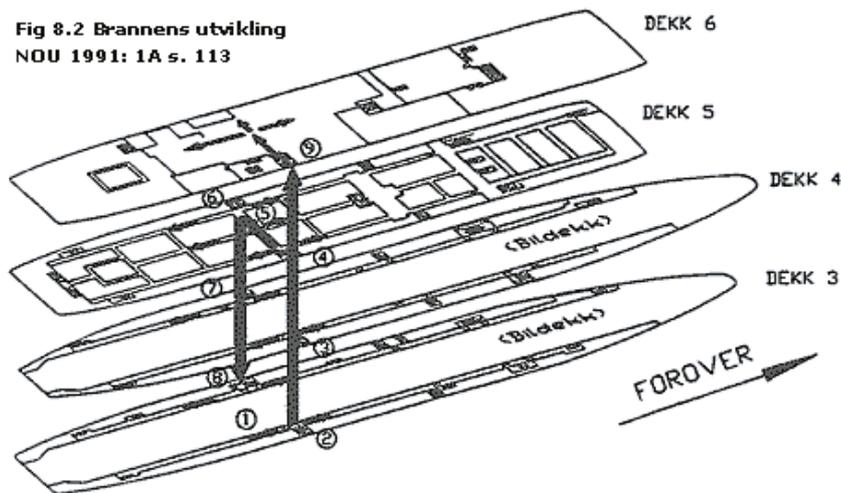
Fire spread timeline for fire no. 2 (positions are denoted with numbers)

1. The fire starts here at approx. 02:00 (hh:mm). 2-8 minutes later the heat release rate reaches 200 kW. This point in time is set to the starting point for the catastrophic fire.

2. The fire is spreading rapidly to this staircase and further upwards.
3. The smoke reaches deck 3 approx. 1 minute after the fire start and spreads to the adjacent corridors ahead and astern the staircase. The fire door ahead the staircase remains open.

4. The smoke reaches deck 5 after approx. 2-3 minutes and starts to spread into the adjacent corridors.
5. The fire spreads from starboard to port through this crossing corridor.

6. On the port side the fire spreads downwards through the staircase.
7. A smaller amount of smoke spreads to the corridors on the port side of deck 4. All passengers in this section were evacuated.

8. The fire spreads down to deck 3 where the fire door leading to car deck is in open position.
9. The fire also spreads into the restaurant section on deck 6 through an open fire door on the top floor of the staircase.

Figure 5. The spread of the main fire (Fire No. 2) throughout the ship. Note that the description of the course of events is a direct translation of description as printed in the NOU 1991:1A report.

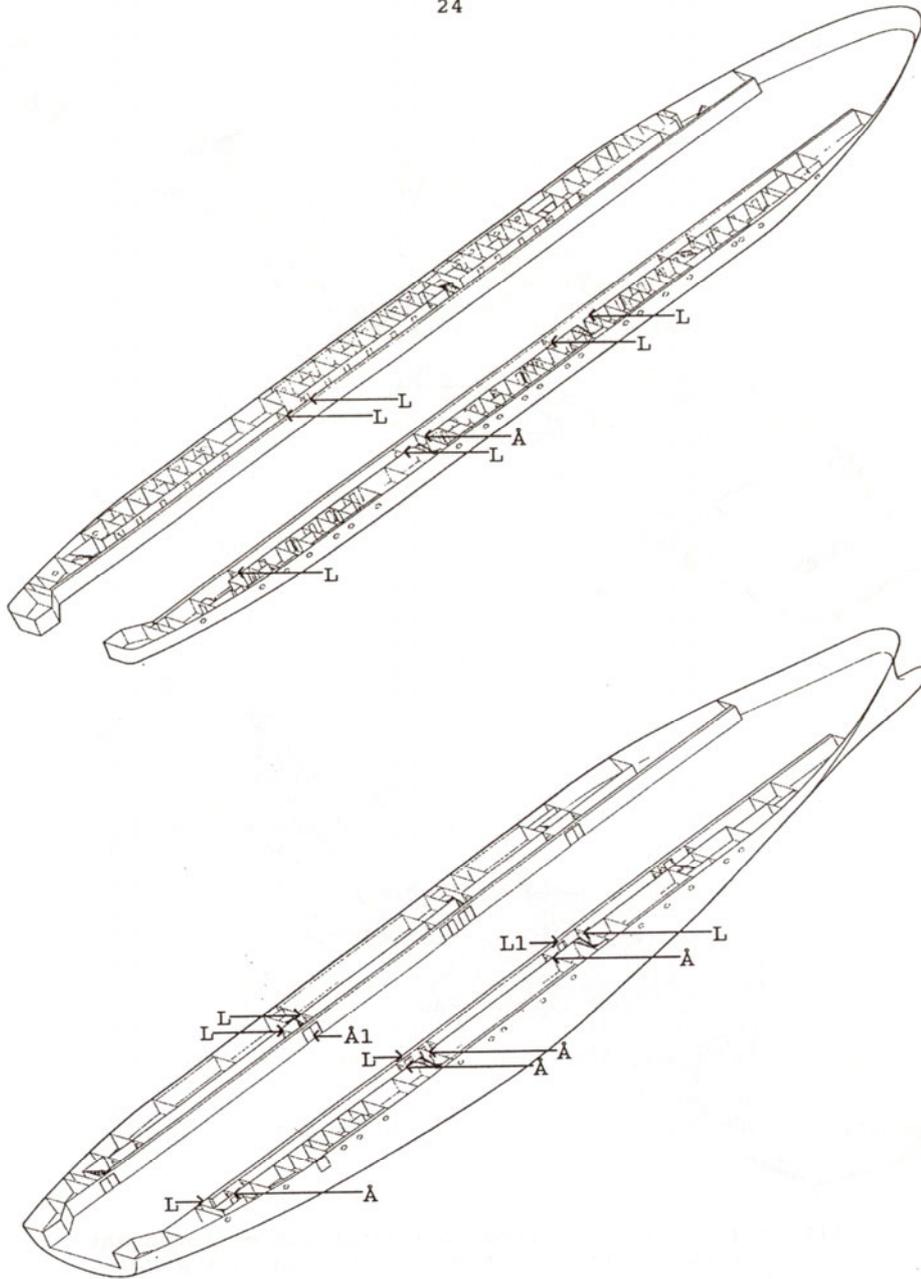
Figure 6. Drawing that shows closed and open fire doors on deck 3 (lower drawing) and deck 4 (upper drawing) which allows fire to spread as described in Figure 5. "A" denotes an open door and "L" denotes a closed door. "A1" denotes that the door is almost fully open and "L1" denotes that there is a leakage caused by either poor sealing or a slit between the door and the doorframe.

Given that a number of fire doors, see Figure 6, were left opened along with that the ventilation system at first was operating normally and then was controlled so that all fans on car deck evacuated air, close to ideal conditions for rapid fire spread were given. This is also the only possible operation for the ventilation system that allows smoke to be sucked down trough D_b (2 BB) in opposite direction of the normal flow direction.

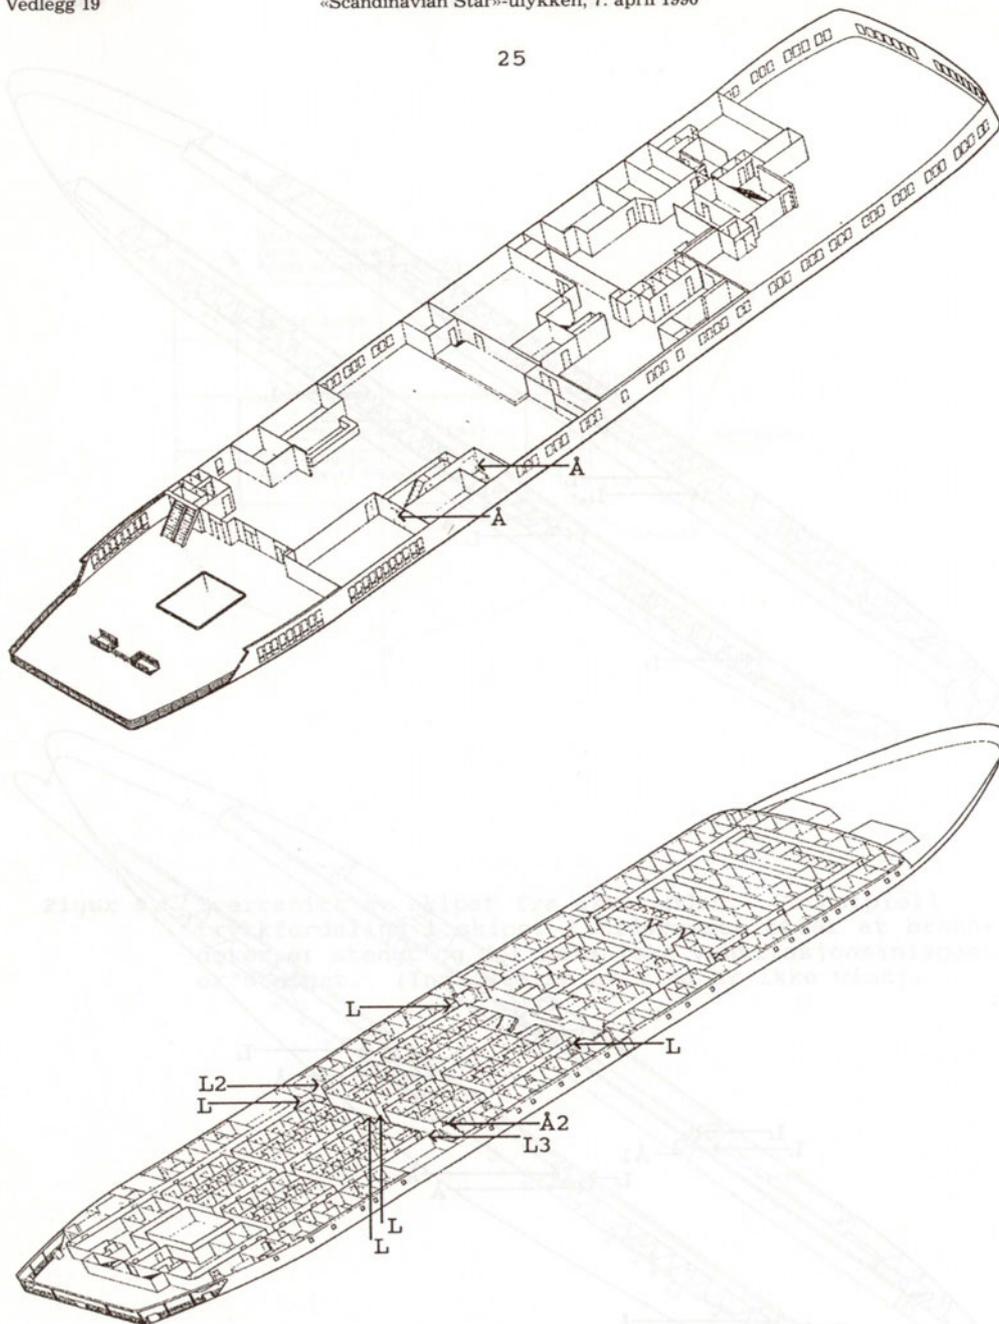
Figure 7. Drawing that shows closed and open fire doors on deck 5 (lower drawing) and deck 6 (upper drawing) which allows fire to spread as described in Figure 5. "Å" denotes an open door and "L" denotes a closed door. "Å1" denotes that the door is almost fully open and "L1" denotes that there is a leakage caused by either poor sealing or a slit between the door and the doorframe "Å2" denotes that the door has been open for a period of time during the fire. "L2" denotes either that the leaking conditions for the door is uncertain or that the door has been shut for a period of time during the fire. "L3" denotes either that the leaking conditions for the door is uncertain or that the door has been shut during the starting phase of the fire.

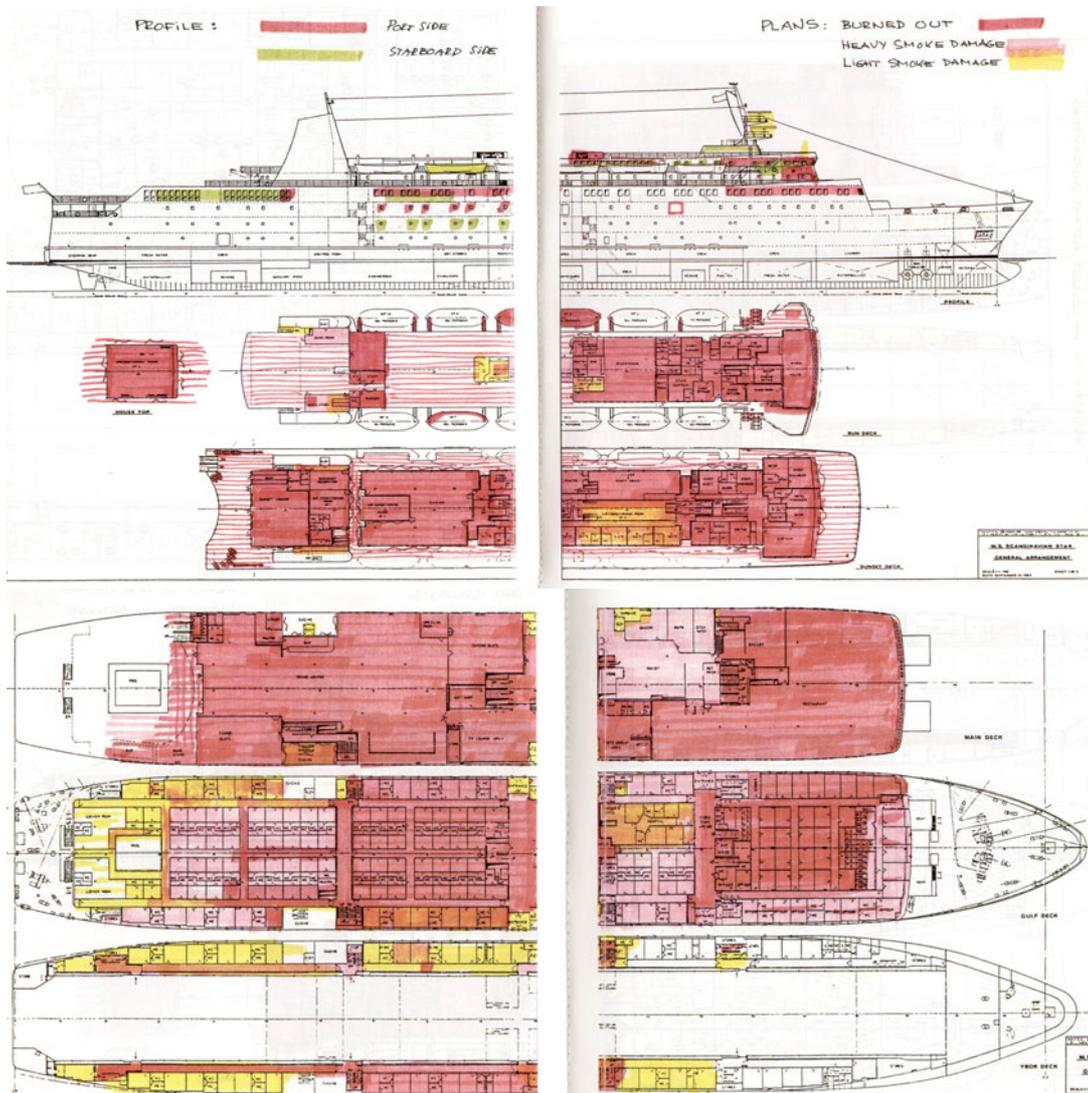
Figure 8. Drawings that show reported damages due to fire on each deck respectively, see also chapter 5.5.1.

Available documentation regarding fire damage on the ship along with the fire scenario calculations carried out by SINTEF indicates that this fire didn't break through the fire compartment division (A 60) towards fire zone 3, see also Figure 8 and chapter 5.6.1.

The official report, regarding the fire damages on the ship (see Figure 8) shows that the front parts of the middle fire zone (zone 2) on deck 5, is, to some extent, only lightly smoke damaged, and in other parts heavily smoke damaged and that the kitchen part on deck 6 (separate fire compartment in fire class A 60) is heavily smoke damaged. This clearly indicates that the fire (fire no. 2) wasn't completely developed in these parts.

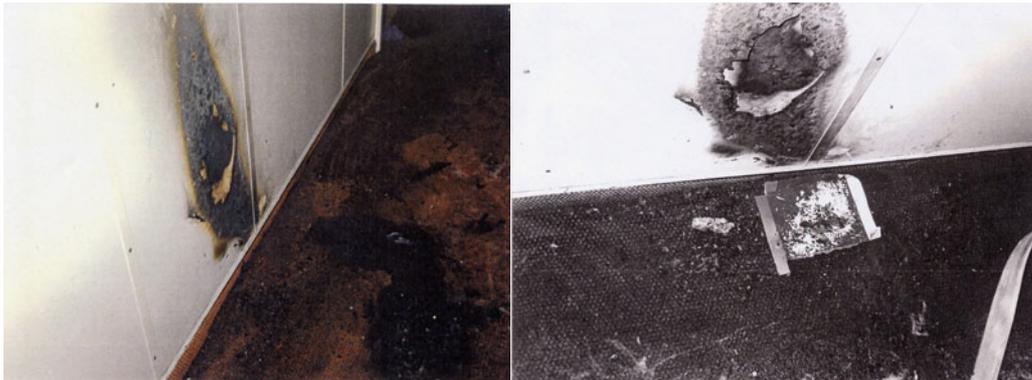
Fire no. 1 started around 01.55 am on the 7th of April 1990 outside cabin 416 on deck 4 (Ybor/Caribbean deck). This fire was discovered early and it was at that time of small magnitude and could therefore easily be put out by passengers and crew members.

Figure 9. Pictures showing the starting location for fire no. 1. The picture on the right includes the piece of cardboard that was used to create a pilot flame.

Fire no. 1 was of no importance for the following chain of events. It is also clear that fire no. 1 was not accidental but was an attempted arson, see Figure 9. According to SOLAS 60 the captain is obligated to activate the evacuation alarm, leading to a total evacuation of the ship, when a fire is detected on board. If the evacuation alarm had been activated at this point it is highly plausible that the number of casualties due to the subsequent fire (no. 2) would have been much lower.

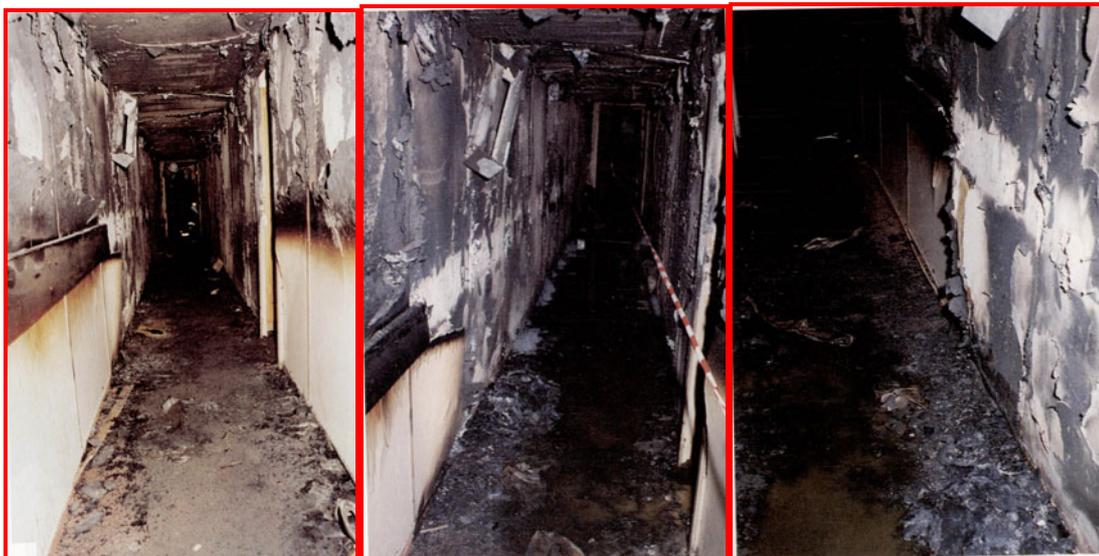
Fire no. 2 started around 02.00 am on the 7th of April 1990 outside cabin 219 on deck 3 (C deck/A deck). This fire is officially denoted as “The main fire”. No fire extinguishing measures are initiated by the captain at this point. The fire accelerates rapidly upwards throughout the ship as described in Figure 5 above.

Figure 10. Three photographs showing damages in the hallway on deck 3, on starboard side of the ship, astern of staircase D_s (2 SB). The door opening, visible to the right in the picture on the left, leads in to cabin 219. Fire no. 2 (the main fire) was started in this hallway.

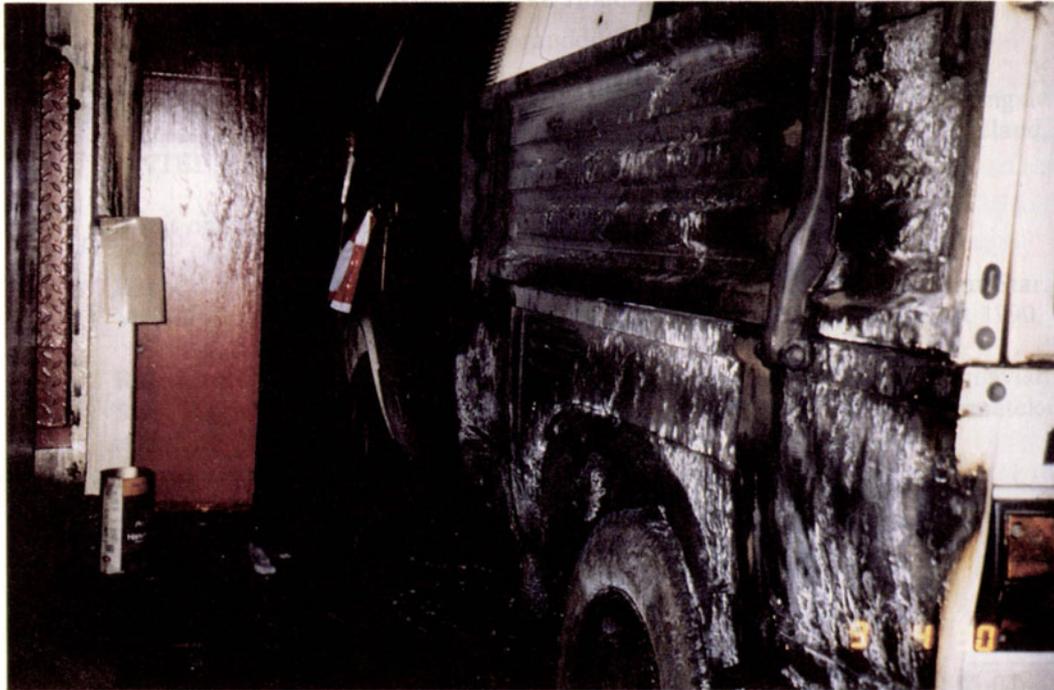
According to eyewitness testimonies, door no. 5 (A 60) between car deck (deck 3) and staircase G_s (3 SB) on the starboard side of the ship was open about 10-15 cm and that door no. 9 (A 60) between car deck (deck 3) and staircase D_b (2 BB) on the port side of the ship was almost completely open (approx. 1 m) during the main fire, see Figure 3 and Figure 11.

Figure 11. Photograph showing a car damaged by fire. The car was parked just nearby the open sliding door no. 9 (A 60), see Figure 3, on the car deck. The air velocity trough this specific fire door opening has been measured to 20 m/s (during a full scale test on board a sister vessel) without the thermal effects from a fire. Note that this velocity refers to cold air. At a smoke temperature of 600°C the velocity increases by approximately a factor 3. This indicates the large effect that the ventilation system would have on the main fire.

Full scale tests carried out by SINTEF aboard Scandinavian Star's sister ship "Jupiter" shows air speed at normal room temperature of approx. 20 m/s across sliding door no. 9 (A 60) between car deck (deck 3) and staircase D_b (2 BB) on the port side. In a fire situation, this air speed has probably been approx. 60 m/s caused by the fact that the invoked gas mix sucked down trough the staircase had a temperature of at least 500-600°C and thus had a density of approx. 1/3 of the density of air at room temperature.

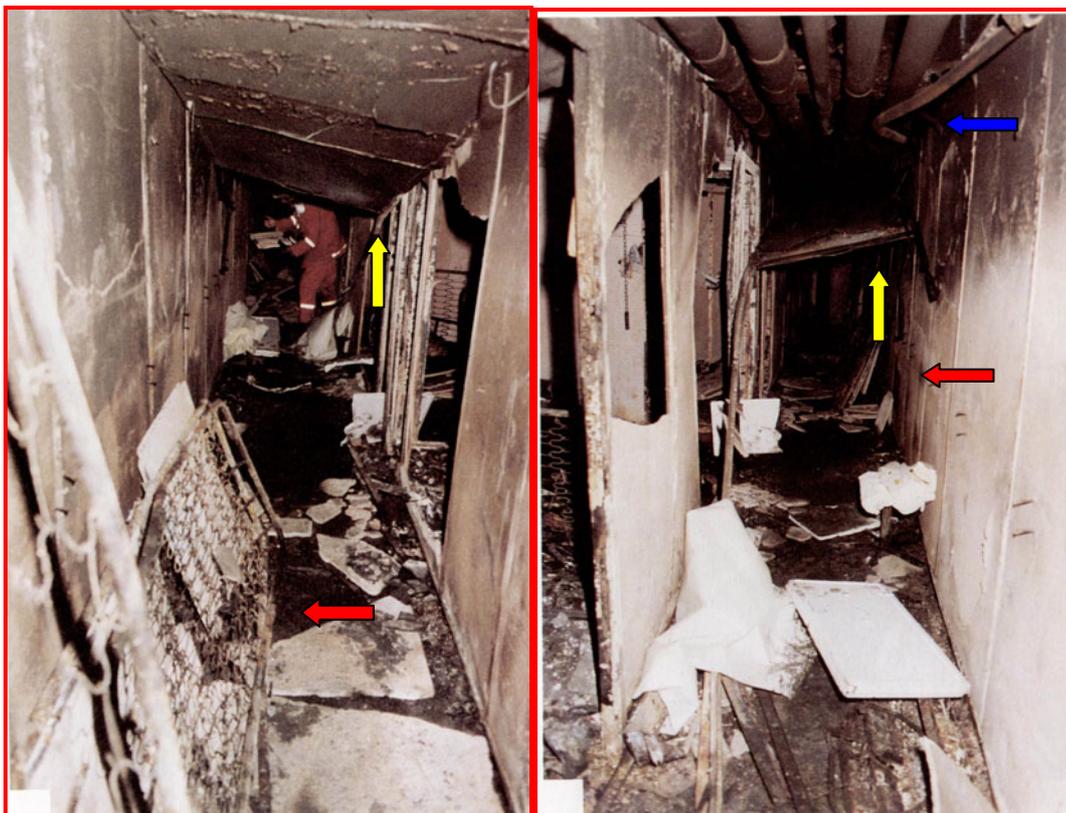
The leaking hydraulic pipe (indicated by a blue arrow in the photograph below on the right) is sharply bent horizontally towards the bulkhead (cabin wall). The other pipes, set in the same ceiling section as the leaking hydraulic pipe, are unaffected by the fire.

Note that only some parts of the ceiling section (indicated by a yellow arrow) that, prior to the fire, was covering the entire pipe zone has collapsed despite the fact that the entire corridor was involved in this fire which indicates that it was destroyed by hand before the fire.

Figure 12. The two photographs show the location for the start of fire no. 3 (the hydraulic fire). On these photographs, the bed (indicated by a red arrow) that most likely has been used to ignite the hydraulic oil is visible. The blue arrow indicates the hydraulic pipe in question. The other pipes, set in the same ceiling section as the leaking hydraulic pipe, are unaffected by the fire. Note that only some parts of the ceiling section (indicated by a yellow arrow) that, prior to the fire, was covering the entire pipe zone has collapsed despite the fact that the entire corridor was involved in this fire which indicates that it was destroyed by hand before the fire.

A hydraulic pipe is constructed and mounted in bulkheads to withstand the very high pressures they are designed for during normal operation. A hydraulic pipe like that, so heavily affected by fire to the extent that it starts leaking oil in a connection, should be bent down on a very long section (notably longer than the distance between the true fixation points since the fixations most likely can't withstand the fire any longer than the hydraulic pipe and its connections) and in a soft arc vertically down towards the cabin sole.

The look of the hydraulic pipe hence indicates that it most likely has been bent to its current position by mechanical damage carried out by human hand and that fire 3 thus most likely was arson. Fire no. 3 resulted in extensive damage on the ship in fire zone 2.

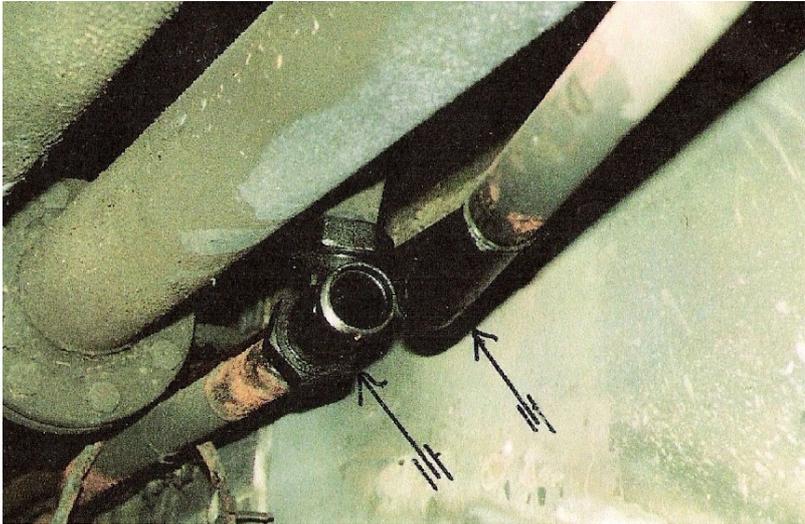
Figure 13. Photograph showing the connection closest to the horizontal bend in the hydraulic pipe in question.

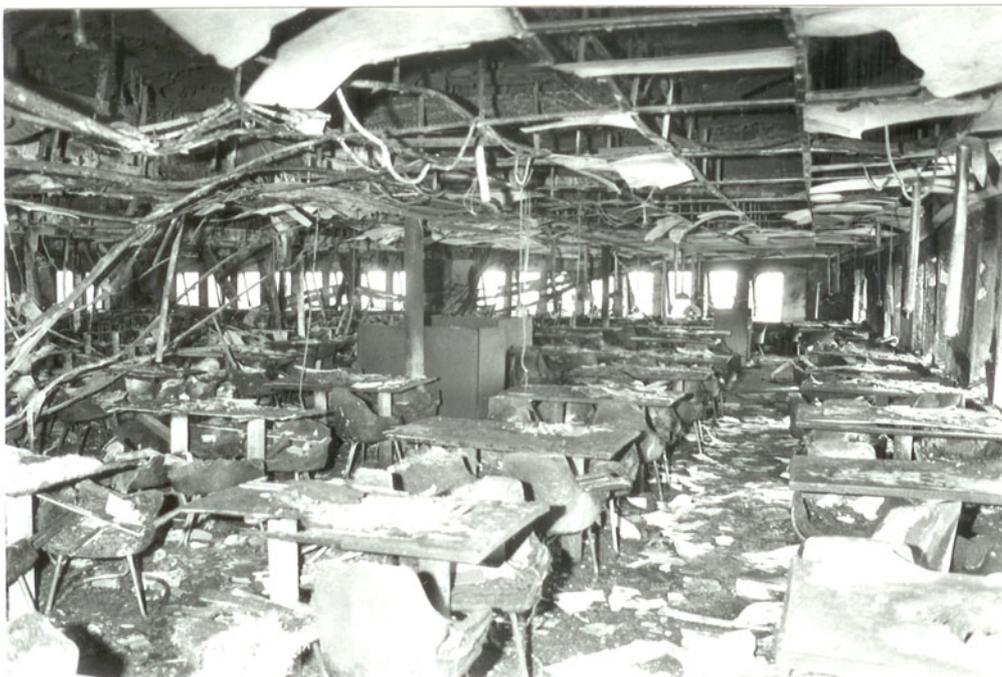
Fire no. 6 starts in fire zone 3 some time after the ship has arrived at Lysekil at 21.17 pm on the 7th of April 1990. Fire no.6 involves the front parts of decks 5, 6, 7, and 8. Note that the first group from the rescue services was lowered from helicopter on to the bow on deck 7 and established command centre in the front, upper part of the ship in connection with the initiation of the fire rescue operations (approximately 3,5 hours after the start of fire no. 2). This clearly indicates that these parts of the ship were not involved in fire no. 2. The fire wasn't extinguished until on the evening of April 8th 1990.

Figure 14. Photograph showing the restaurant in the front part of deck 6. The heavy fire damages are most likely the effects of fire no. 6.

Available documentation regarding the fire damages on the ship indicates that it is most unlikely that the documented damages in fire zone 3 is an effect of natural fire spread from fire zone 2 (fires no. 2 and 3). The fact that the upper front part of the ship was used as a command centre for the rescue operation, also shows that this part of the ship was unaffected by the fire before the ship had arrived at Lysekil. This is further confirmed by the fact that permanent smoke ventilation of the parts affected by fire in the middle and stern parts of the ship was established already around 11.30 (see also chapter 5.2).
