Package / Item:	Bascule span to the Railway bridge "Jernbanebroen over Limfjorden"
Supplier:	MT Højgaard
Purpose of visit:	Production & Quality Surveillance – Steel structure Visit No. 3
Location / Address:	Tarcon Tarnobrzeg Poland

Date of Visit / Review: 2012-09-05 to 2012-09-06

Bascule span to the Railway bridge "Jernbanebroen over Limfjorden"

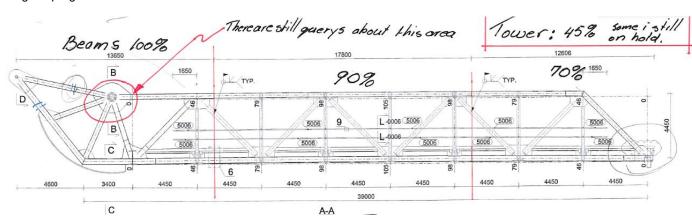
Stage of progress at the visit

None of the elements have got any surface treatment yet. Rambøll was informed that it takes approximately 7 days to sandblast and paint an element.
