ENVIRONMENTALLY FRIENDLY COASTAL PROTECTION

PRESSURE EQUALISATION MODULES

COST-EFFECTIVE AND ENVIRONMENTALLY FRIENDLY COASTAL PROTECTION

FIELD RESEARCH REPORT

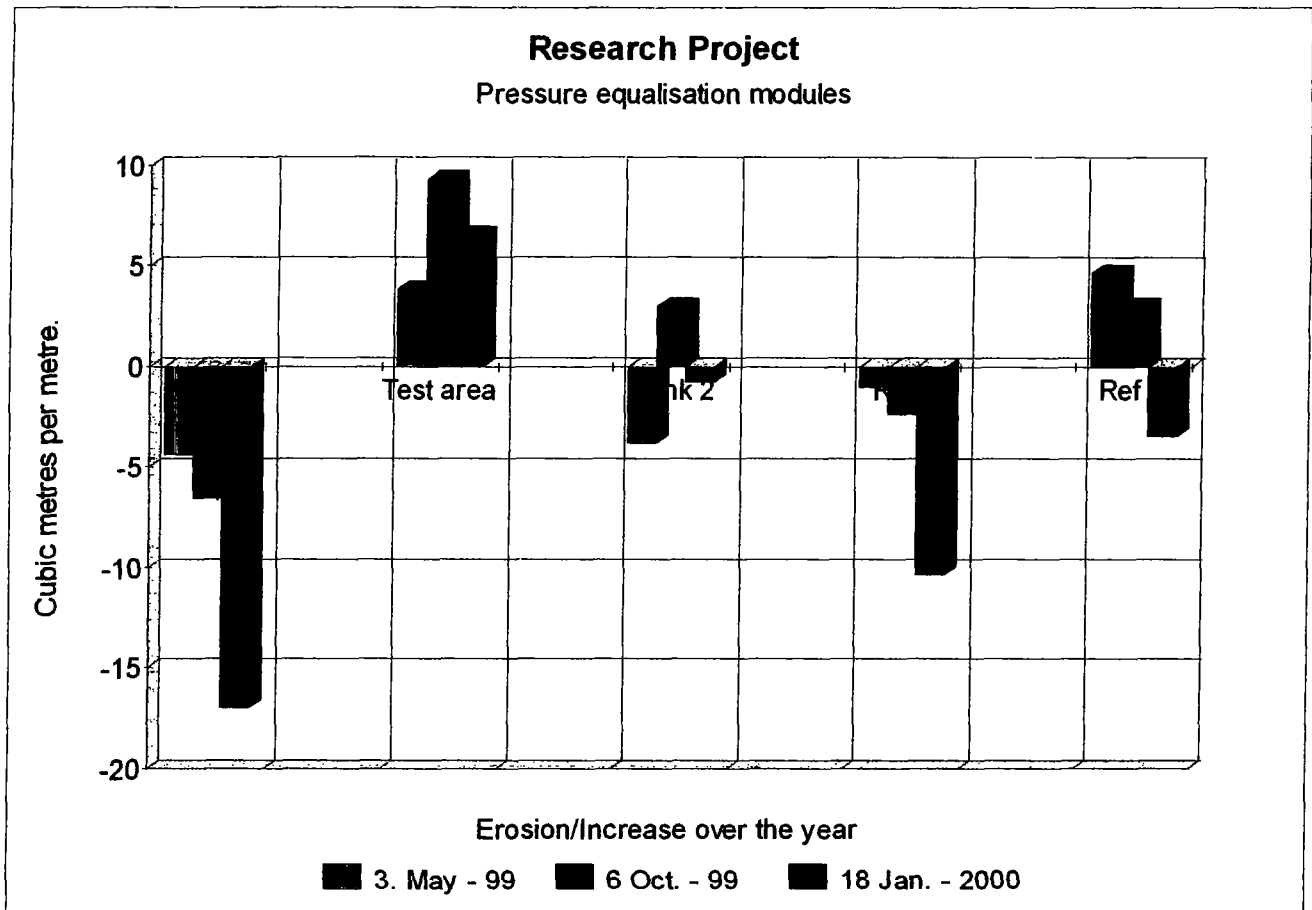
Diagram 3. The development of each of the monitored profiles over the twelve-month period.

The measurements were made between January and October of 1999 and January 2000 and comprise the test area with pressure equalisation modules as well as the nearby reference areas, each 1 kilometre long. The following results were observed:

Site	Results	Quantity	Unit
Test area	accumulation	9350.00	cubic metres
Reference area I	erosion	2363	cubic metres
Reference area II	accumulation	3035	cubic metres

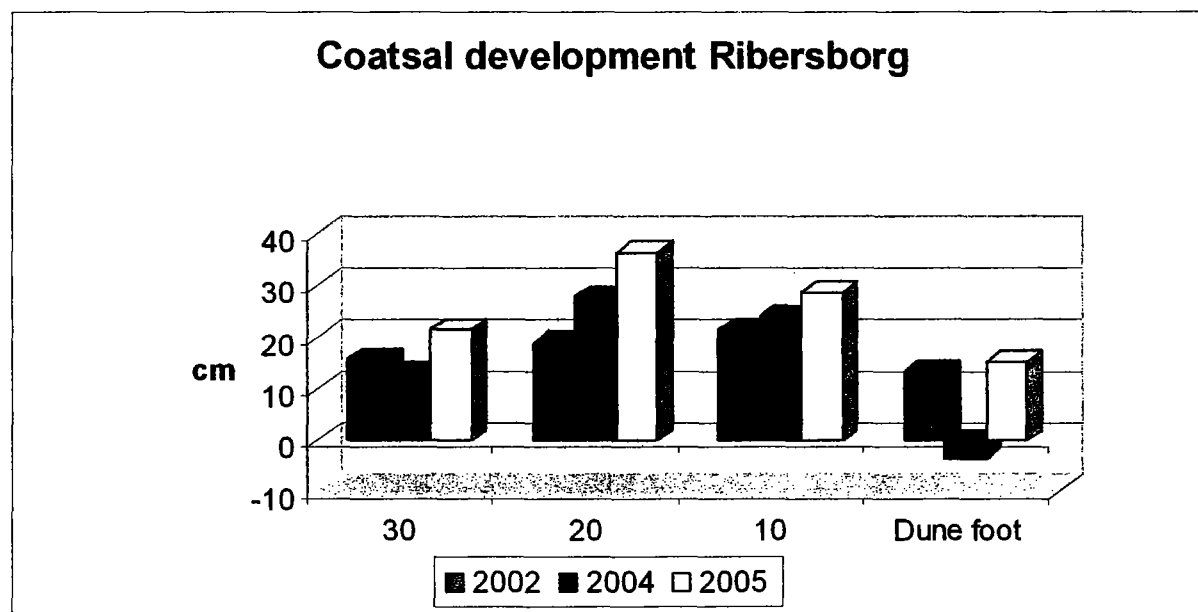
Gennemsnitlig strandudvikling i 30 meters brede 2002
 Gennemsnitlig strandudvikling i 30 meters brede 2004
 Gennemsnitlig strandudvikling i 30 meters brede 2005

Average	Delta
18,8 cm	
21,7 cm	2,9 cm
28,8 cm	7,1 cm.

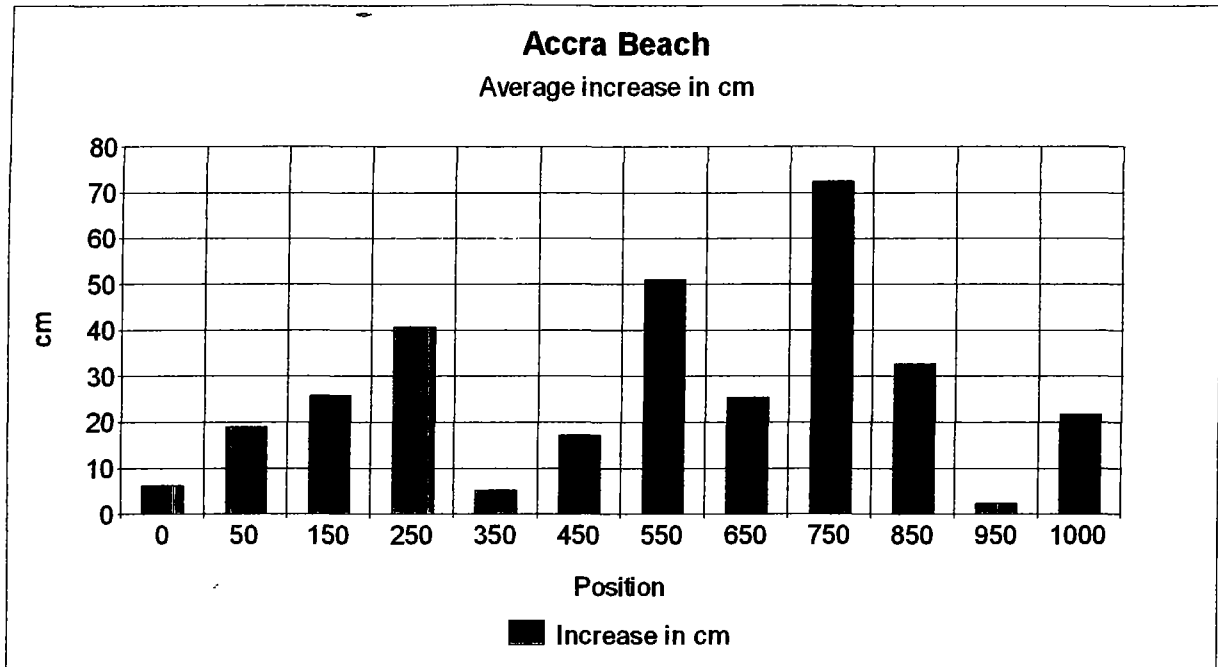
Survey

The coastline was measured July 18, 2000 by Rudan in cooperation with Carl Bro. It is important that an impartial control body carried out the measurement.

The average raise in the profile on the 66,600 m² was 26.66 cm, which shows an increase of 17.76 m³ per running metre along the pressure equalised coastal profile on Accra Beach.
