#### REPORT

**Ref.** : Santa Francisca Pig Farm.

# Report Santa Francisca

Environmental Assessment: Review of environmental conditions at SANTA Francisca farm (part of Coexca), Chile

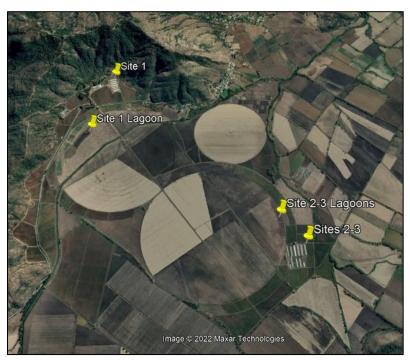
Source: Own production based on Google Earth.

According to our observations on the onsite visit to the Farm, the slurry management system located on Site 1 currently operates with one 5,000 m<sup>3</sup> capacity accumulation lagoon which is not waterproofed on its base, nor covered on its upper part.

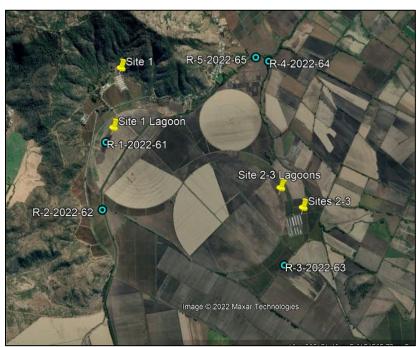
The following image shows the zone from where the samples were obtained:

Source: Own production based on Google Earth.

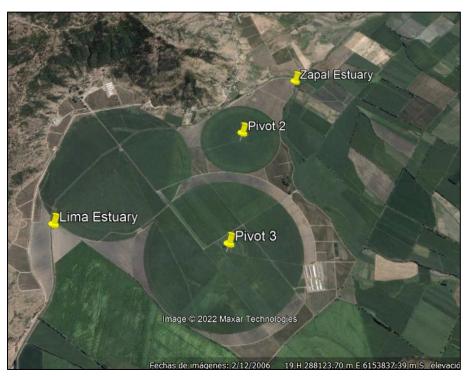
Thus, even though Pivot N°2 passes close to the Zapal channel, it does not cover it, and an approximate distance of 10 meters of separation exists from its closest point.

Regarding Pivot N°3, the irrigation system is very far away from the stream.

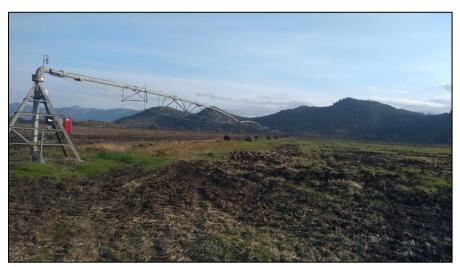
Source: Own production.

Notwithstanding the foregoing, it should be noted that the SAP indicates that the phreatic water table of the fields is located between 2 to 4 meters below the surface, therefore there is no certainty to stand that the three operational accumulation lagoons are or are not leaking some percentage of it, due to the fact that they are not waterproofed on its bottom.

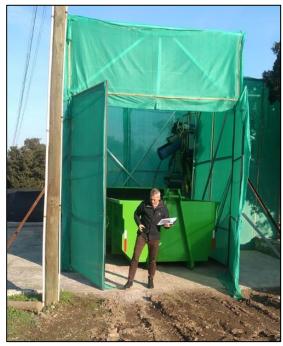
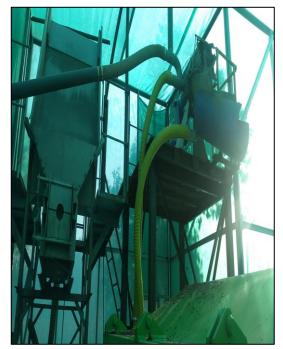
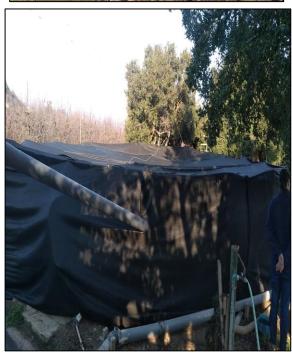
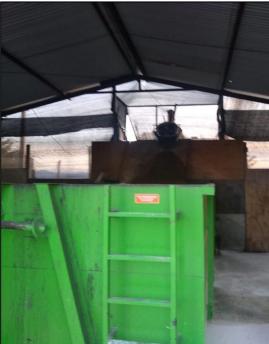
• Improvement of the reception system of the solid part of the slurry in a container, instead of its disposal on the ground, which was also covered with mesh to avoid vector production. The homogenizer well was also covered.

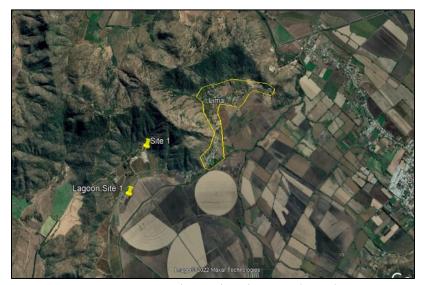
Source: Own production based on Google Earth

Finally, please note that there is no certainty that the waterproofed ponds are not infiltrating into the phreatic water table.

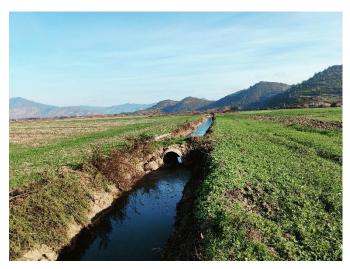
Image 3.A: Connection to lagoon 1

# 3.1 Lagoon 1 at site I: 5,000 m<sup>3</sup>

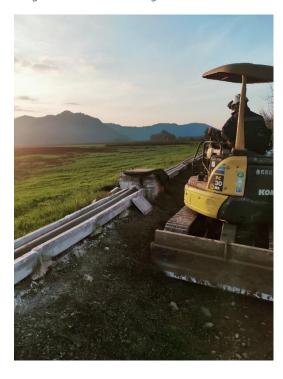
Image 3.C: Connection to lagoon 2-5

# 3.2 Lagoon II/III: 1,250 $m^3$ + 1,250 $m^3$ (and future Lagoon 4 and 5 of 9,000 $m^3$ + 9,000 $m^3$ ) at site II/III:

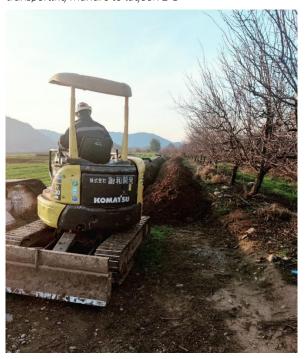
*Image 3.D: Preparation for burying closed pump line for transporting manure to lagoon 2-5*

It is stated that all slurry pipes will be changed to buried, closed pump lines by July 2022. This also applies to slurry lines/pipes at the slurry separation plants.

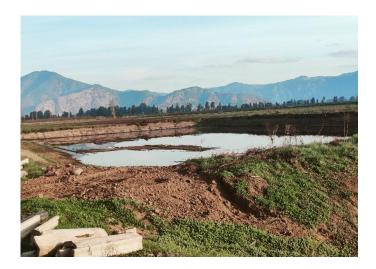
Image 3.E: Lagoon 2 and 3 (will be closed down)

- When all slurry transports have been converted to buried, closed pump pipelines, EU standards for this are met.
- Lagoons 2 and 3 will be dismantled and replaced with lagoons 4 and 5 which will be established with a solid bottom and cover in accordance with EU standards.

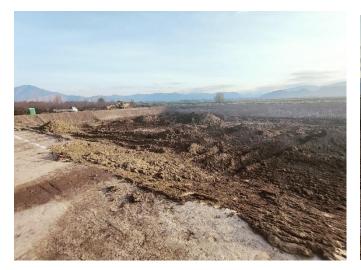
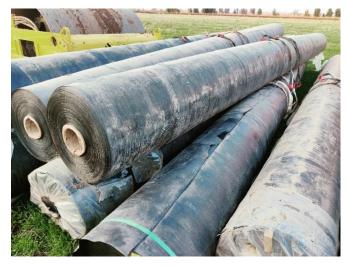
Image 3.F: Establishment of lagoon 4-5

# 3.3 Lagoon 4 and 5 at site II/III: 9,000 m<sup>3</sup> + 9,000 m<sup>3</sup> (under establishment)

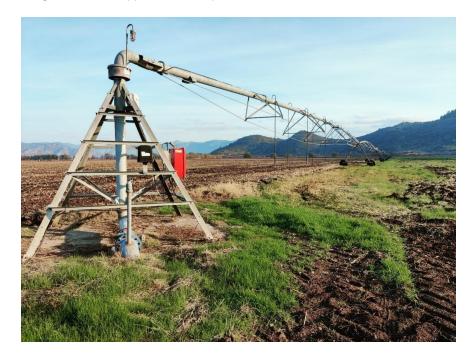
Image 4.A: Manure application technique

Approximately 11.8 DE/ha is applied to the application areas, corresponding to 960 kg N/ha/year. EU rules allow a maximum of 1.7 DE/ha, corresponding to 170 kg N/year, but 204 kg N/ha/year for application of only wet fraction after slurry separation, which is the case at Santa Francisca. Nitrogen application at Santa Francisca is still calculated to be higher than what EU standards.

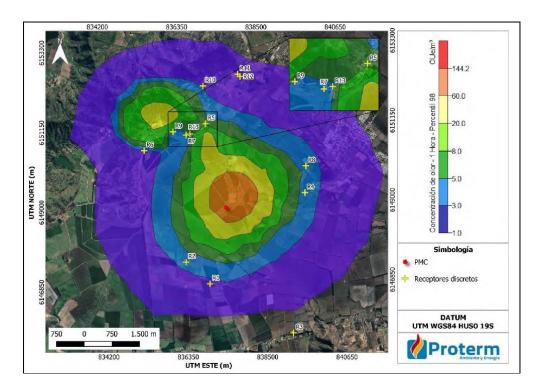
It has by the Chilean company Proterm (www.proterm.cl) been calculated (04 de marzo de 2022 - Inf02E01.O-22-021) that the farm's odour emission at the nearest urban area is less than 3 Ou/m³ and a few of the nearest settlements 5-20 Ou/m³.

In comparison, the limit value for urban zones in the Danish Livestock Act is 5 Ou/m<sup>3</sup> at urban areas, 7 Ou/m<sup>3</sup> at smaller villages and 15 Ou/m<sup>3</sup> at settlements in the countryside. In a previous report, NIRAS A/S (report date 14-09-2016) has estimated the same values of odour from the farm in the area.

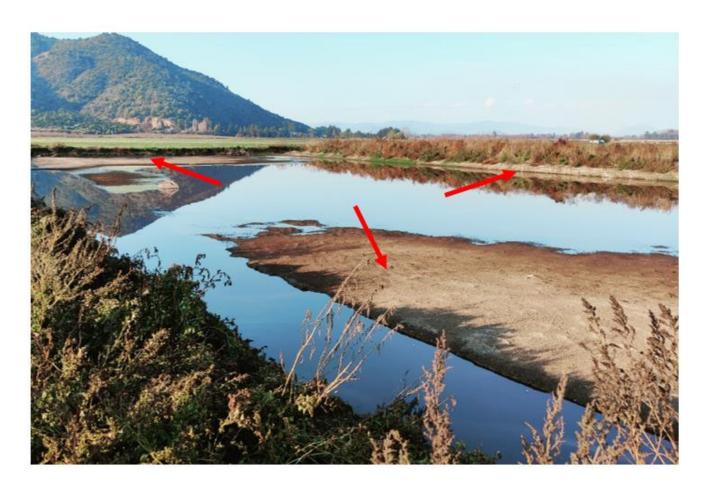
Image 5: Lagoon 1. Possible propagation place for flies.

Flies from livestock farms are propagated primarily in solid manure which is not removed or covered for a period of more than 3-4 weeks. As the solid part of the slurry is stored in a container and transported away from the property every 14 days, this activity will not contribute to significant fly nuisances. Since the solid part of the slurry is no longer applied on the property's land, but transported to an external composting company, the application of manure will also not contribute to fly nuisances in the area. However, the non-covered Lagoon 1 is very likely to be the propagation site for a significant number of flies. This is due to the fact that on parts of the slurry surface and on the sides of the lagoon, solid fractions are formed, which will be a potential site for propagation of flies. This is illustrated in image 5. As it is stated by the farm that Lagoon 1 will be established with solid bottom and cover in September 2022, the problems with the propagation of flies in Lagoon 1 are expected to be solved.
