**Redegørelse i anledning  
af tre havarier  
med Dash8 Q400**

**Bilag til redegørelsens kap. 6**

**Hæfte 1**

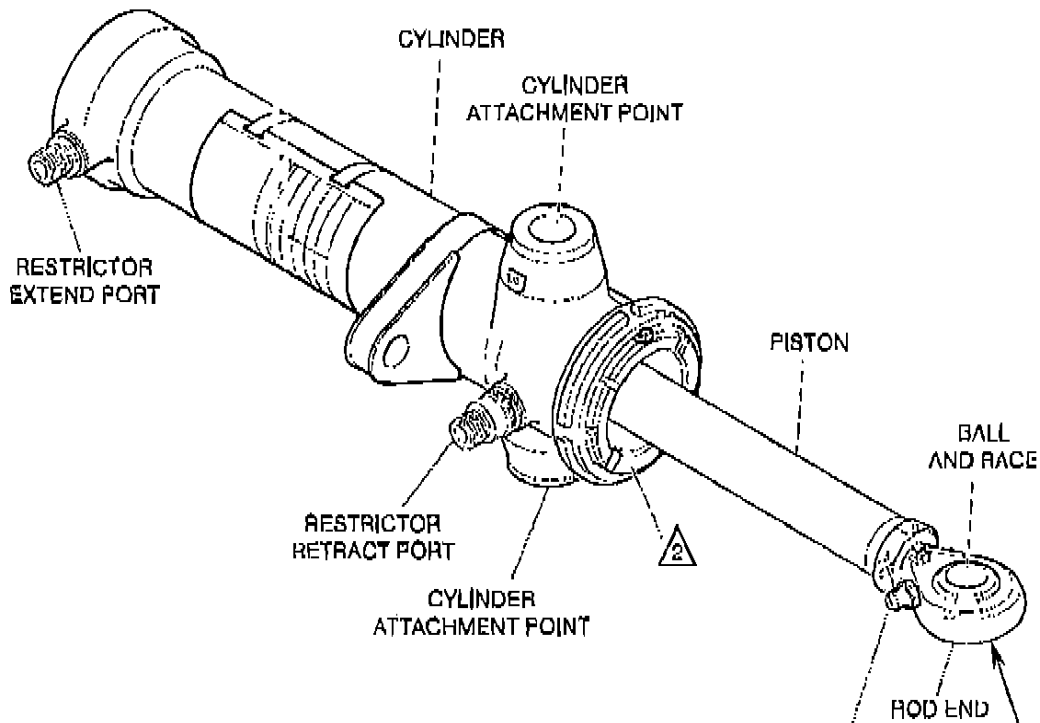
Retraction actuator assembly p/n 46550-7/-9

Inspect affected parts for any signs of corrosion or wear.

Remove the rod end of the retraction actuator assembly in accordance with SCR 086-07 rev. ~~REV~~ A.

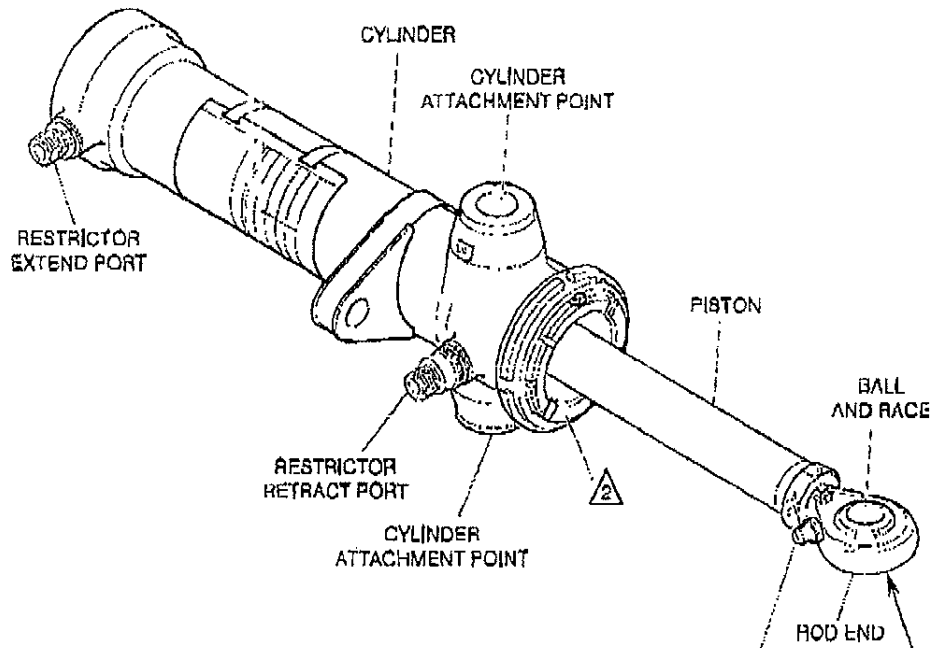
Retraction actuator assembly p/n 46550-7/-9

Inspect affected parts for any signs of corrosion or wear.

Remove the rod end of the retraction actuator assembly in accordance with SCR 086-07 rev. ~~A~~ B

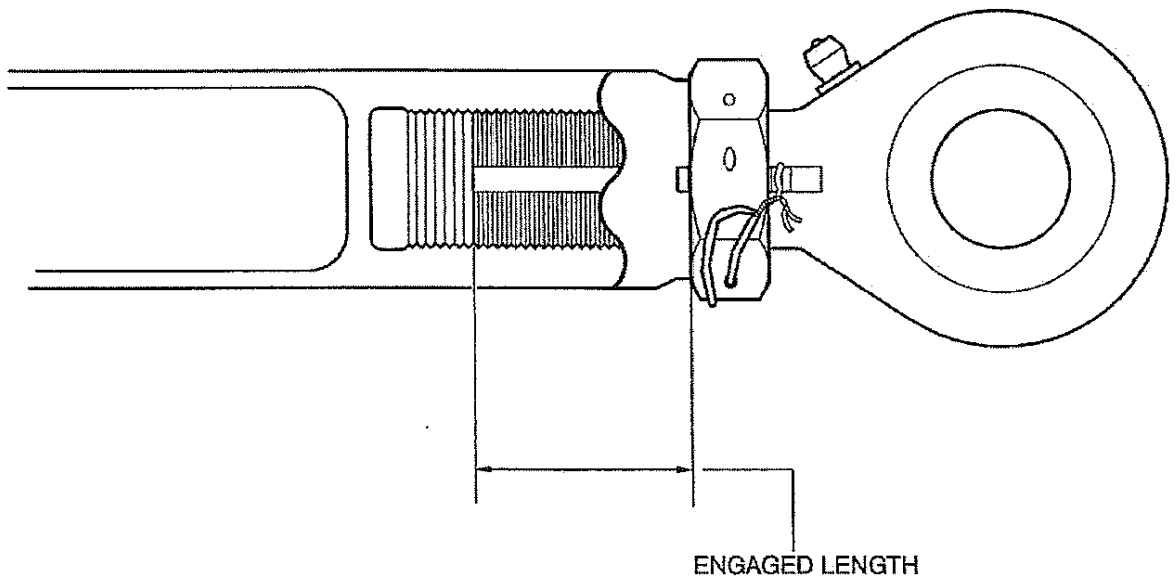
**FIGURE 2**

- 4. ACCEPTANCE CRITERIA**
- A) LIGHT SURFACE CORROSION (NO PITTING) OVER THE ENTIRE THREADED LENGTH WITH AT LEAST FIVE CONSECUTIVE FULL UNDAMAGED THREADS WITHIN THE ENGAGED THREAD LENGTH (REF FIGURE 2) IS ACCEPTABLE FOR **1000 FC OR 6 MONTHS** (WHICH EVER OCCURS FIRST) OF CONTINUED SERVICE. RETRACT ACTUATOR TO BE INSPECTED TO ENSURE JAM NUT IS SECURE AND WIRE LOCK IS IN PLACE EVERY **100 FC**.
