**Redegørelse i anledning
af tre havarier
med Dash8 Q400**

Bilag til redegørelsens kap. 6

Hæfte 2

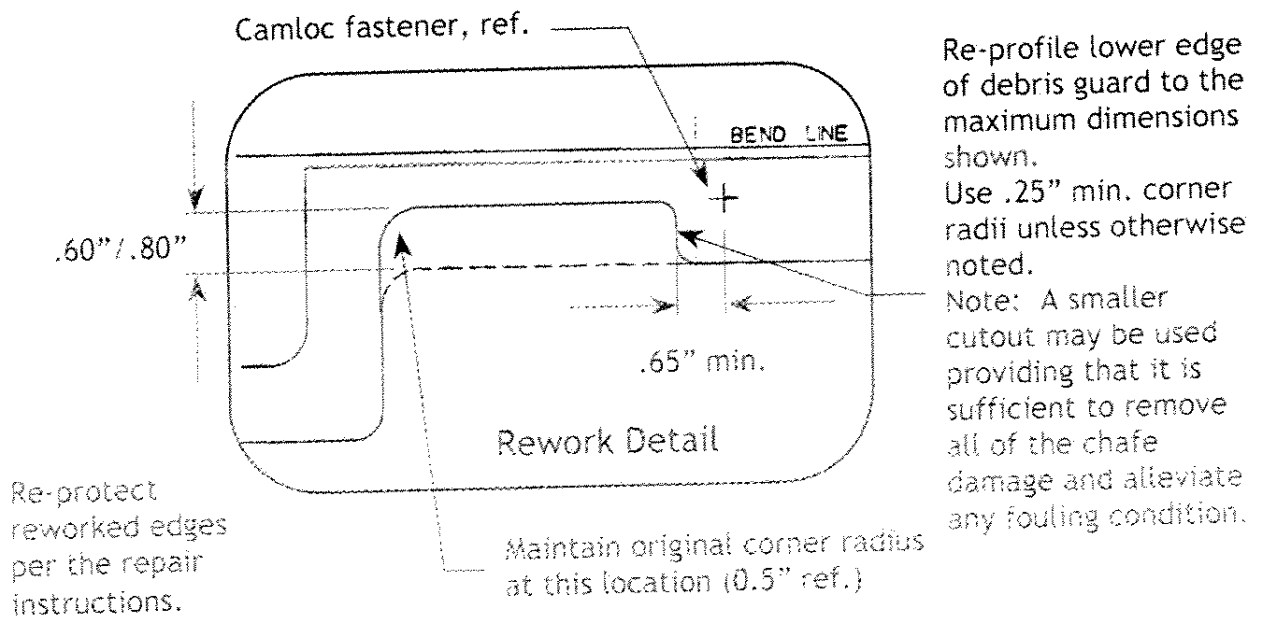
10 ISSUE	1				2 RD NUMBER	3 SECTION	4 SHEET
					8/4-32-064	1	3

View looking fwd on debris guard showing location of rework

Repair Instructions

Maintain maximum cutout dimensions and minimum distance to the adjacent Camloc as shown on Sheet 2. Ensure that all chafe damage is removed by the cutout.

Note: In lieu of the maximum cutout shown on Sheet 2 a smaller cutout may be used provided that the min. corner radii and distance from the Camloc is maintained and that all of the damage has been removed.

2. Perform a detailed visual inspection of the edge of the debris guard to ensure that the reworked area is free of delamination - no delamination permitted.
3. Apply epoxy adhesive, ref. Table 2, Item 13 or 14, per generic RD 8/4-51-030, along the edge of the cutout to re-seal the edge of the debris guard. Allow epoxy adhesive to cure fully and sand lightly as required to obtain a smooth edge.
4. Apply polyurethane enamel in accordance with the instructions of the DASH 8 Structural Repair Manual, PSM 1-84-3, Chapter 51-25-15.
5. Re-install debris guard in accordance with the original engineering drawings or per the applicable task in the aircraft maintenance manual.
6. Inspect the nose landing gear mechanism to ensure that there is no fouling of the spring assembly with the debris guard through the full range of motion.

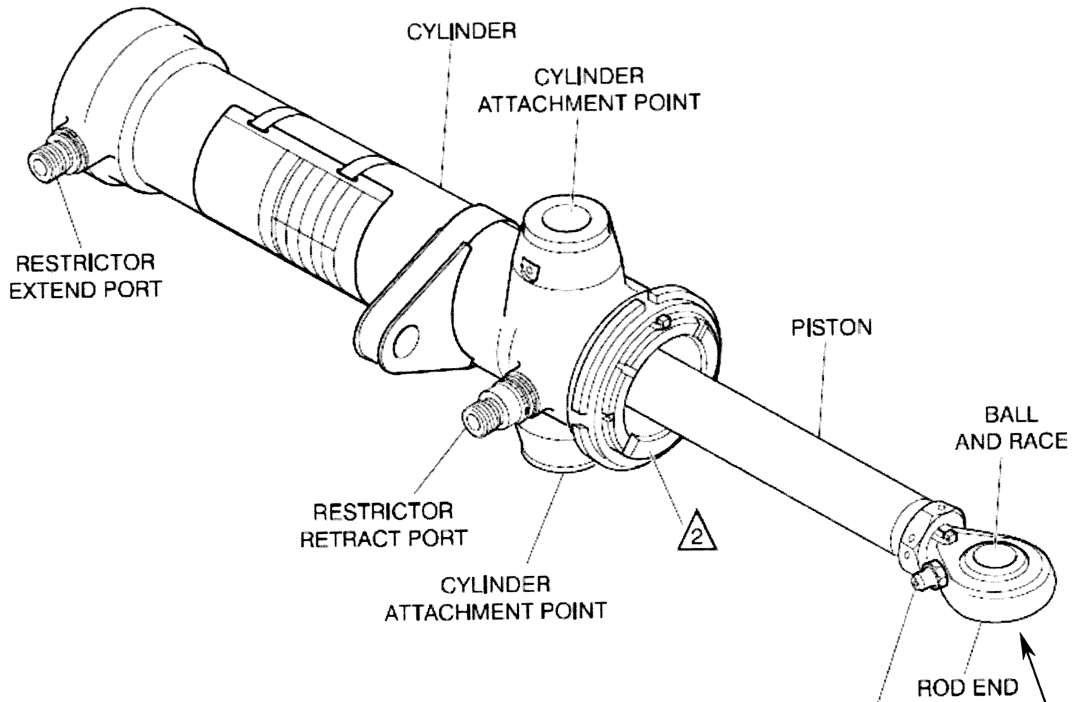
Retraction actuator assembly p/n 46550-7/-9

Inspect affected parts for any signs of corrosion or wear.

Remove the rod end of the retraction actuator assembly in accordance with SCR 086-07 rev. D

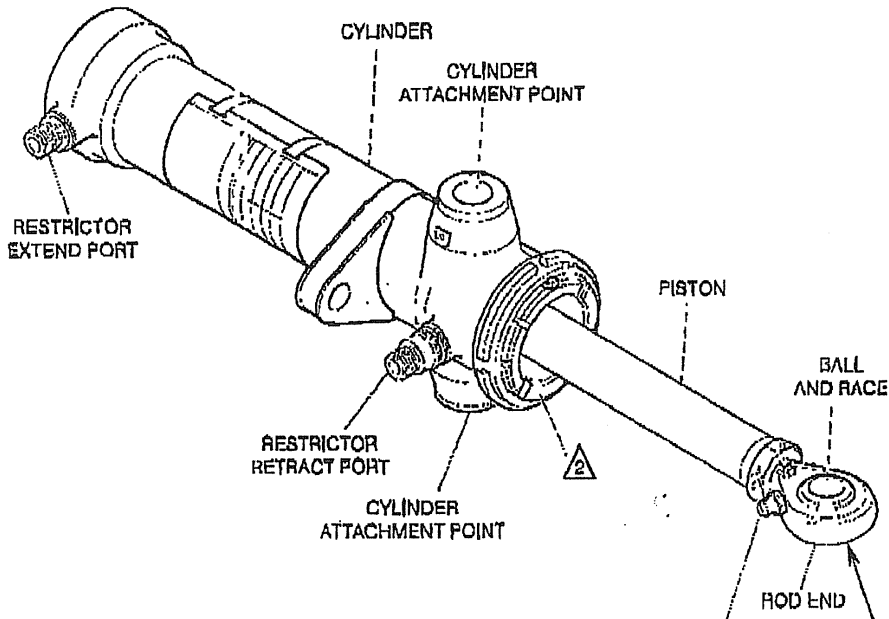
Retraction actuator assembly p/n 46550-7/-9

Inspect affected parts for any signs of corrosion or wear.

Remove the rod end of the retraction actuator assembly in accordance with SCR 086-07 rev. ~~A~~ ~~B~~ **C**

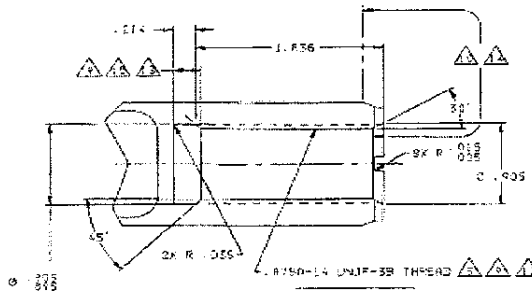
FIGURE 1

10. VISUALLY INSPECT PISTON (P/N 46570-1/-3) THREADS AND THREAD RELIEF AREA FOR EVIDENCE OF CORROSION AND/OR DAMAGE AND/OR PITTING (REF. FIGURE 1), USING BORESCOPE OR 10X MAGNIFICATION MIRROR UNDER ADEQUATE LIGHTING CONDITIONS.

1. MASK AS REQUIRED TO PROTECT ACTUATOR HOUSING, GLAND AREA, AND EXPOSED CHROME OF PISTON FROM F.O.D CONTAMINATION AND DAMAGE DURING THE FOLLOWING REWORK.
2. CHASE PISTON THREADS AND THREAD RELIEF AREA TO REMOVE CORROSION PRODUCTS TO THE GREATEST POSSIBLE EXTENT USING THREAD COMB AND/OR STAINLESS STEEL WIRE BRUSH.
3. INSPECT THE ENTIRE PROFILE OF THREADS OVER THE FULL SPAN OF THREADS (REF. 1.836 DIM, FIGURE 1) AND THE RELIEF GROOVE IN PISTON USING 10X MAGNIFICATION MIRROR OR BORESCOPE UNDER ADEQUATE LIGHTING CONDITIONS.

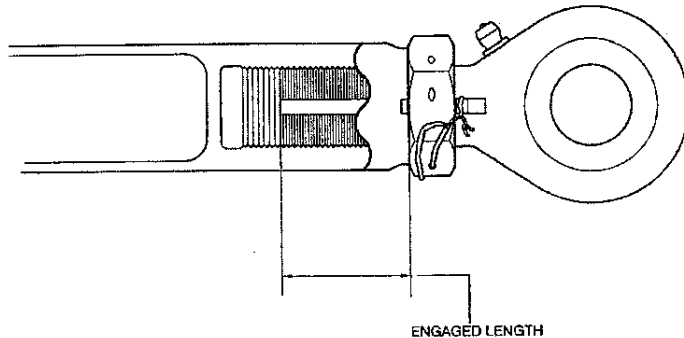
FIGURE 2

A) LIGHT SURFACE CORROSION (NO PITTING) OVER THE ENTIRE THREADED LENGTH WITH AT LEAST FIVE CONSECUTIVE FULL UNDAMAGED THREADS WITHIN THE ENGAGED THREAD LENGTH (REF FIGURE 2) IS ACCEPTABLE FOR **1000 FC OR 6 MONTHS** (WHICH EVER OCCURS FIRST) OF CONTINUED SERVICE. THE RETRACT ACTUATOR IS TO BE INSPECTED TO ENSURE JAM NUT IS SECURE AND WIRE LOCK IS IN PLACE EVERY **100 FC**

B) EVIDENCE OF MODERATE PITTING CORROSION CAN BE REWORKED: (REF FIG 2)

FOR OPTION a) THE RETRACT ACTUATOR IS TO BE INSPECTED TO ENSURE JAM NUT IS SECURE AND WIRE LOCK IS IN PLACE EVERY **100 FC**.

IF JAM NUT IS FOUND LOOSE DURING FLIGHT CYCLE ALLOWANCES GRANTED BY THE CRITERIA IN 4A) OR 4 B), RE-TORQUE JAM NUT TO 660-980 INB-LBS AND SAFETY LOCKWIRE PER MS 33540.
