SCANDINAVIAN STAR

Fire on board 070490-080490

FIRE INVESTIGATION

Preliminary study
Malmö, Sweden, 2009-07-09
SWECO Fire Protection Engineering and Risk Management

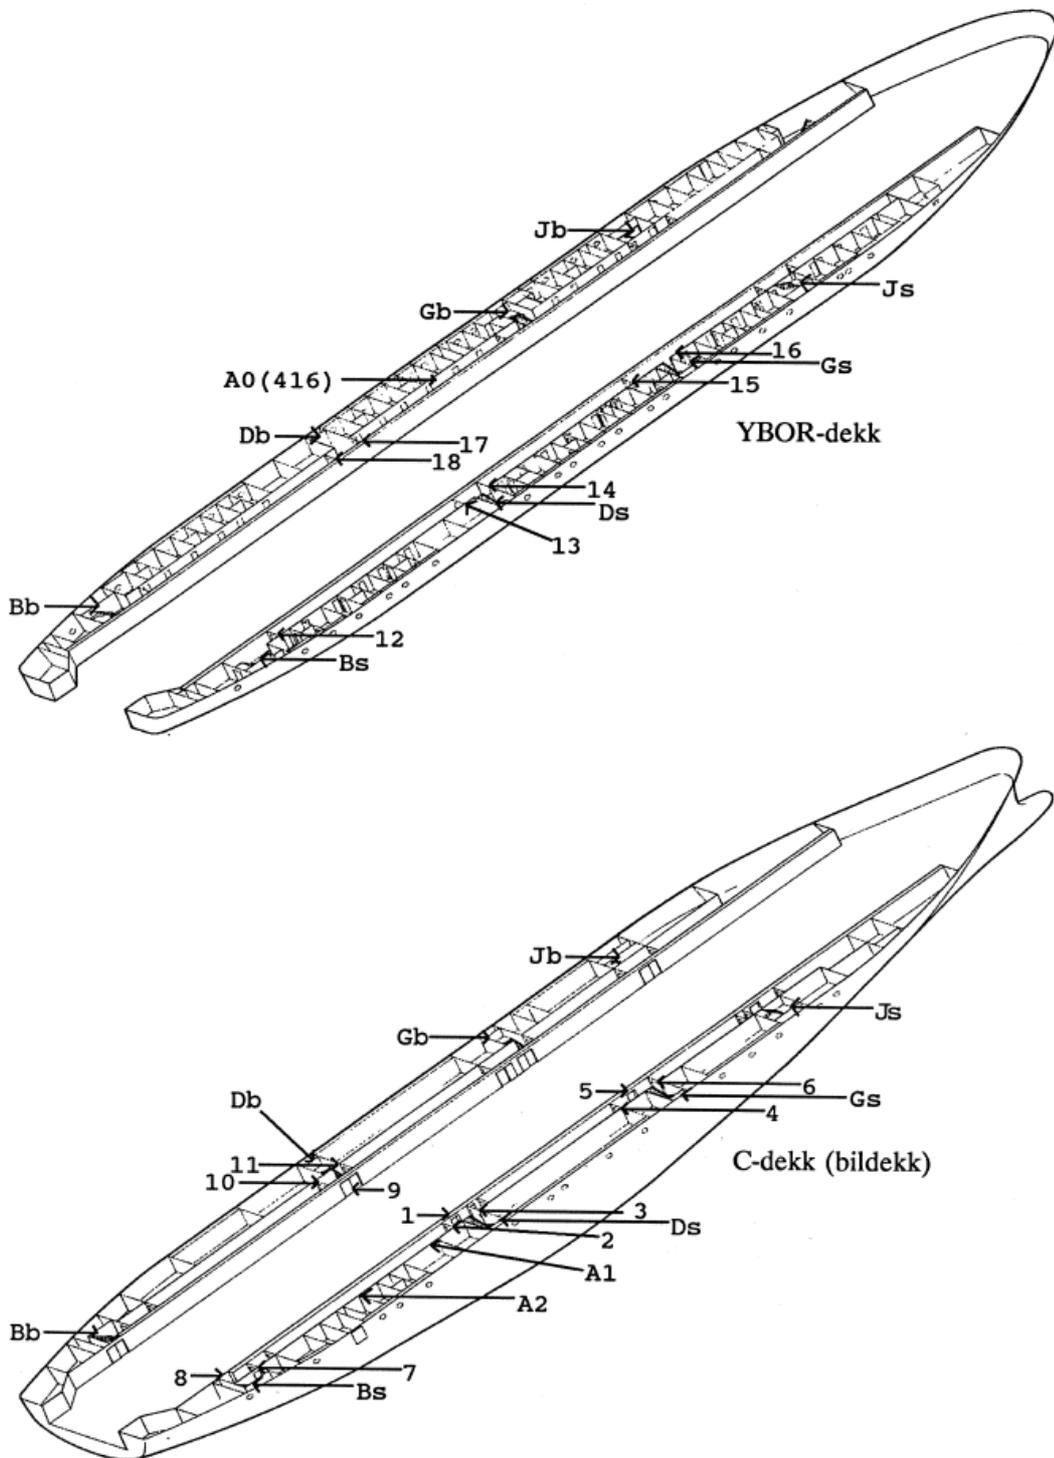
Figure 3. Overview showing door and staircase notations for Ybor deck (deck 4) and C deck (deck 3).

According to eyewitness testimonies, door no. 5 (A 60) between car deck (deck 3) and staircase G_s (3 SB) on the starboard side of the ship was open about 10-15 cm and that door no. 9 (A 60) between car deck (deck 3) and staircase D_b (2 BB) on the port side of the ship was almost completely open (approx. 1 m) during the main fire, see Figure 3 and Figure 11.
